# **Preserving the Orbiter: Stabilization, Disassembly, Relocation and Storage of an Historic Space Shuttle Mock-Up**

**John Griswold**

**Griswold Conservation Associates, LLC, Los Angeles, CA USA**

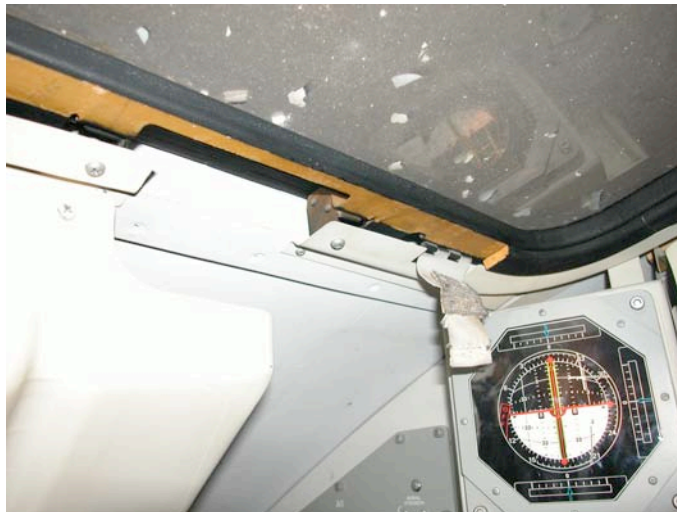
Missing section of simulated rubber insulation on ceiling window of flight deck. Note exposed pine wood. Debris has fallen onto the top of the glass from the ceiling.

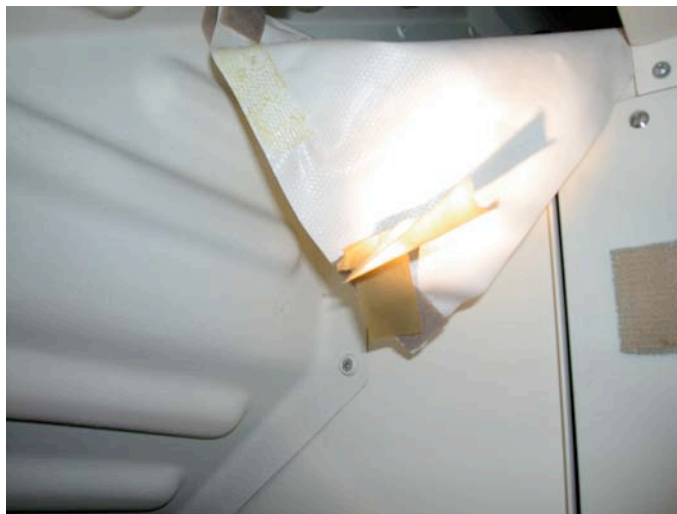
missing fasteners, and vinyl plastic coverings were losing their grip due to embrittlement of the adhesive holding the Velcro® patches to the painted plywood. These were secured using temporary means including cotton twill tape ties where possible. Where the weight of hanging, degraded plastic sheeting posed a risk of further tearing, it was removed and stored separately.

Torn vinyl plastic sheeting and degraded adhesive tape and Velcro attachments on flight deck.

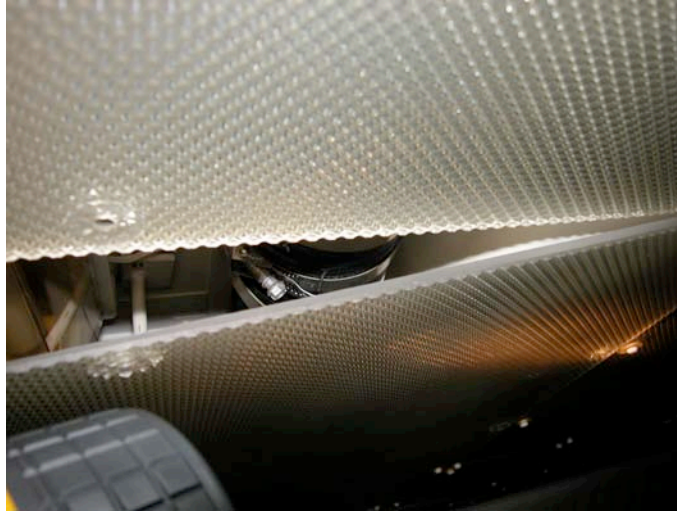
Some items were found to be damaged or loose. These required stabilization in place in anticipation of jolts and vibration during the moving process. Several of the clear plastic, prismatic light panels in the crew quarters were cracked and/or loose due to

Failing fasteners at prismatic lighting lenses made of acrylic.

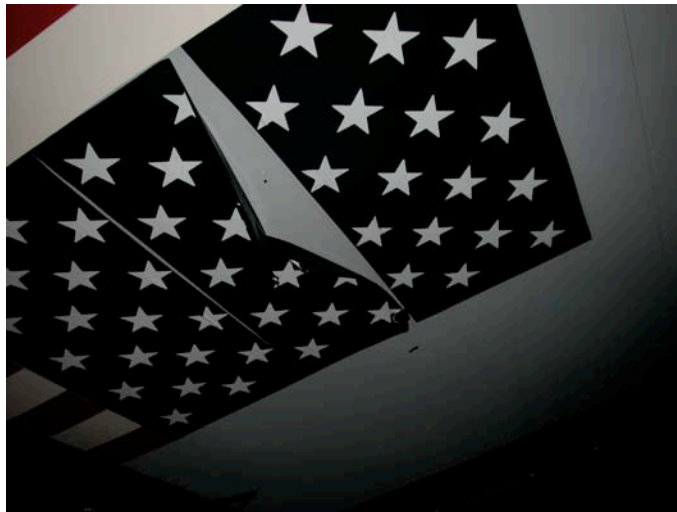
American flag decal on underside of wing is detaching from the painted plywood substrate.

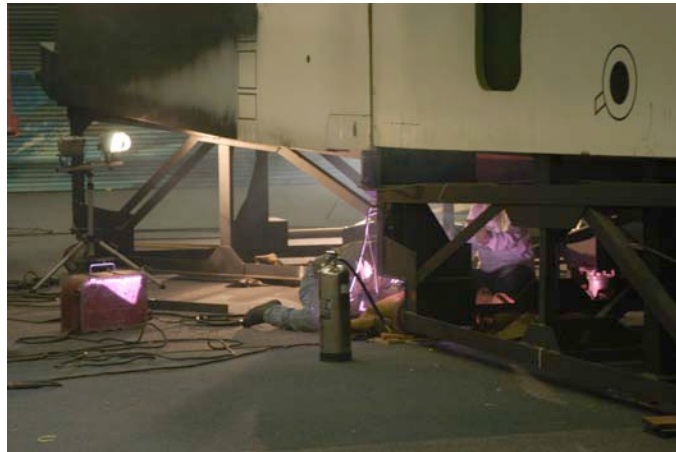
Welders adding additional bracing and joint reinforcements to existing steel trusswork supports under fuselage.

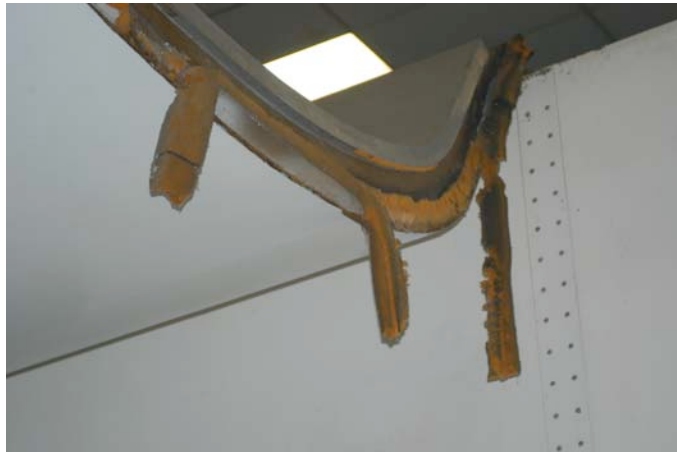
Hanging shreds of urethane foam gaasketing at edge of payload bay door.

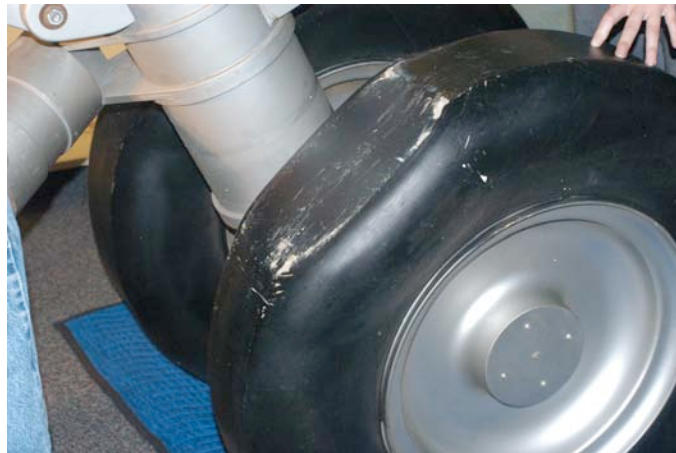
Detail of the underside of the nose landing gear assembly showing deliberately flattened portion of the painted wooden tires. Note chip loss and abrasions.

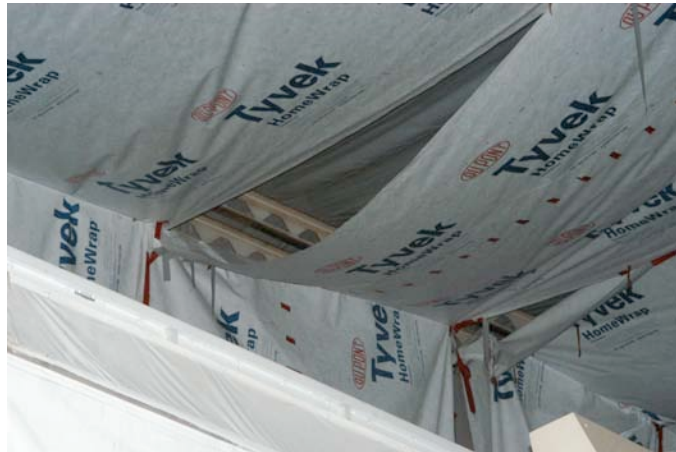
The Tyvek® envelope remains generally intact after one year, with some minor gaps where the tape adhesion has not been properly re-established. These areas appear stable, but reinforcement with simple alligator-type clips may be recommended in the future.

Early failure of improperly sealed tape joints in the Tyvek wall.

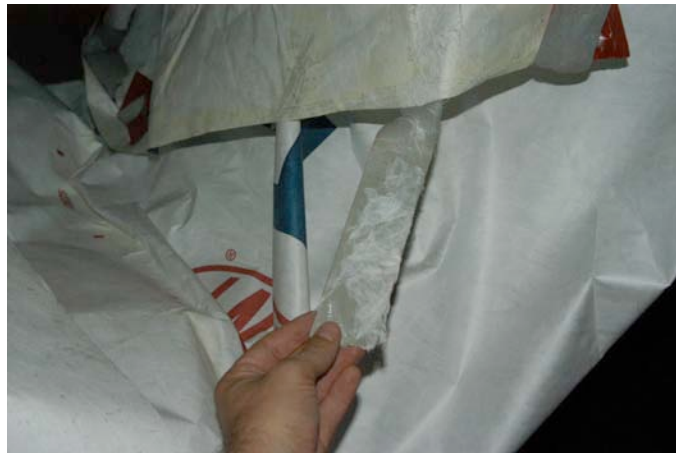
Failure of tape joints at the ceiling level caused some sheets to fall. Inspection of the tape joints lower down showed that the adhesion between the tape and the Tyvek could be quite strong when properly attached.

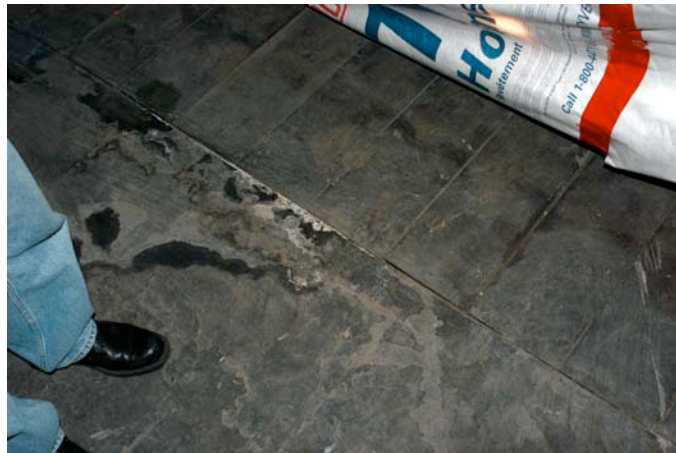
There have been water leaks in the roof near the southwest corner of the enclosure, with some pooling of rainwater near the outer barrier wall. Sandbags have been brought in as a protective measure here, and water was removed immediately using wet/dry industrial vacuum units. Absorbent booms are now to be placed around the entire perimeter of the enclosure.

Winter rains revealed a building roof leak not apparent during initial inspections. Water entered the storage tent at the perimeter on the south side, but did not contact the Mock-up.

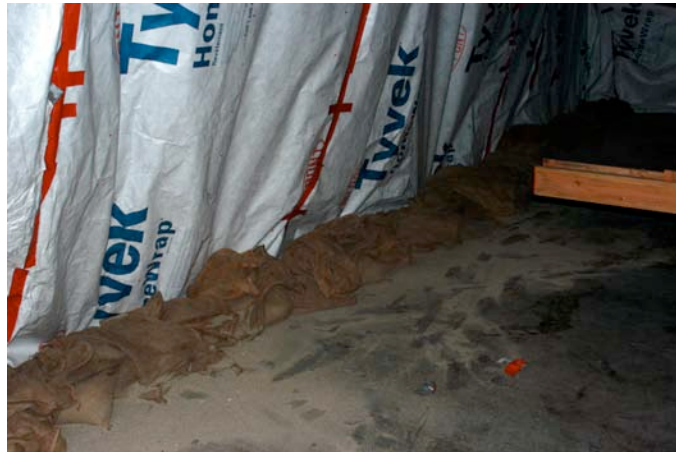
Sandbags were hastily deployed along the path of travel of the water leak.
