ASTP
FLIGHT READINESS REVIEW BOARD

VOL. II SPACECRAFT-ROCKWELL

APOLLO-SOYUZ TEST PROJECT
CSM 111/DM-2/DS 5/SLA 18
FLIGHT READINESS REVIEW
PREBOARD REPORT
JSC

4 JUNE 1975

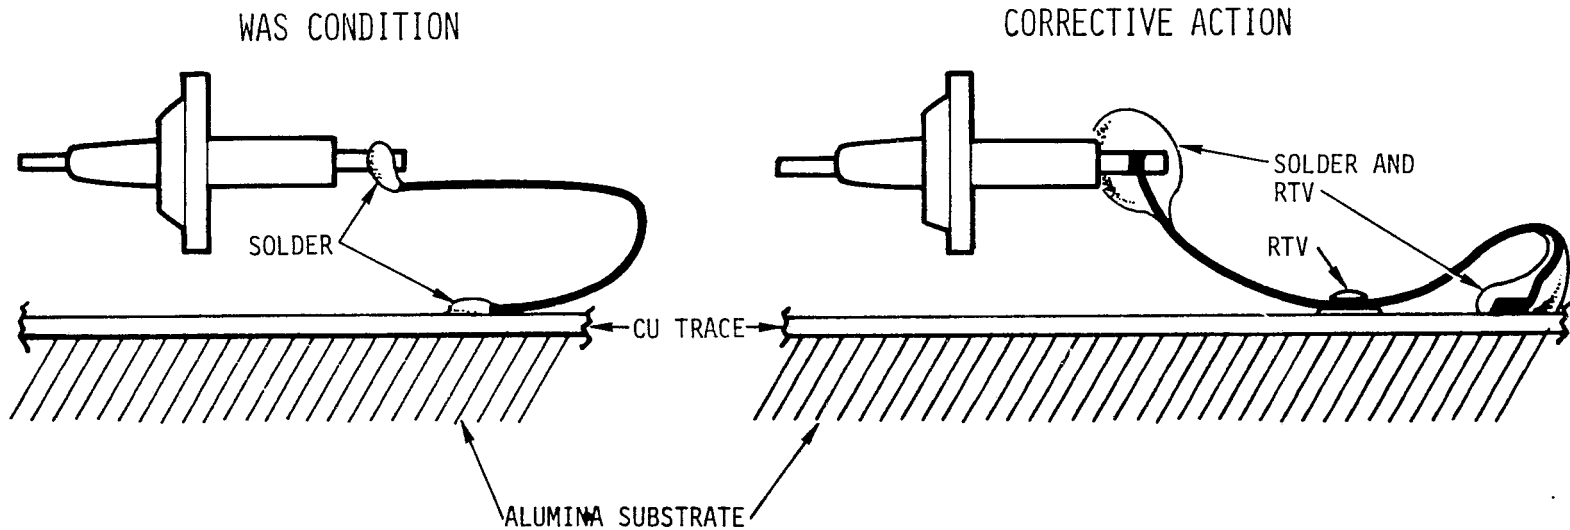
ATS-6 POWER AMPLIFIER VIBRATION TEST FAILURE

SN	EVENT DESCRIPTION	PROBLEM CAUSE	RESOLUTION
003	QUAL VIBRATION FAILURE - 3 BROKEN B+ WIRES	LOOSE TERMINAL LOAD, B+ WIRE FATIGUE FAILURE, & PWR SUPPLY COMPONENTS LOOSE	CORRECTIVE STAKING POTTED POWER SUPPLY
003	QUAL VIBRATION FAILURE - RESISTOR MOUNTING BLOCK FAILURE	LACK OF STAKING & MARGINAL DESIGN	REDESIGN SUBSTITUTE DELRIN FOR TEFLON
001	PS DYNAMIC FAILURE OUTPUT VOLTAGES ERRATIC (LOST VOLTAGE REGULATION)	LOOSE TERMINAL (IMPROPERLY STAKED)	REPAIRED PWR SUPPLY & CONCLUDED QUAL DYNAMIC TEST

B+ LEAD INSTALLATION

- POT FINAL AMPLIFIER B+ TERMINATIONS WITH RTV & RTV LEAD CENTER TO SUBSTRATE BASE

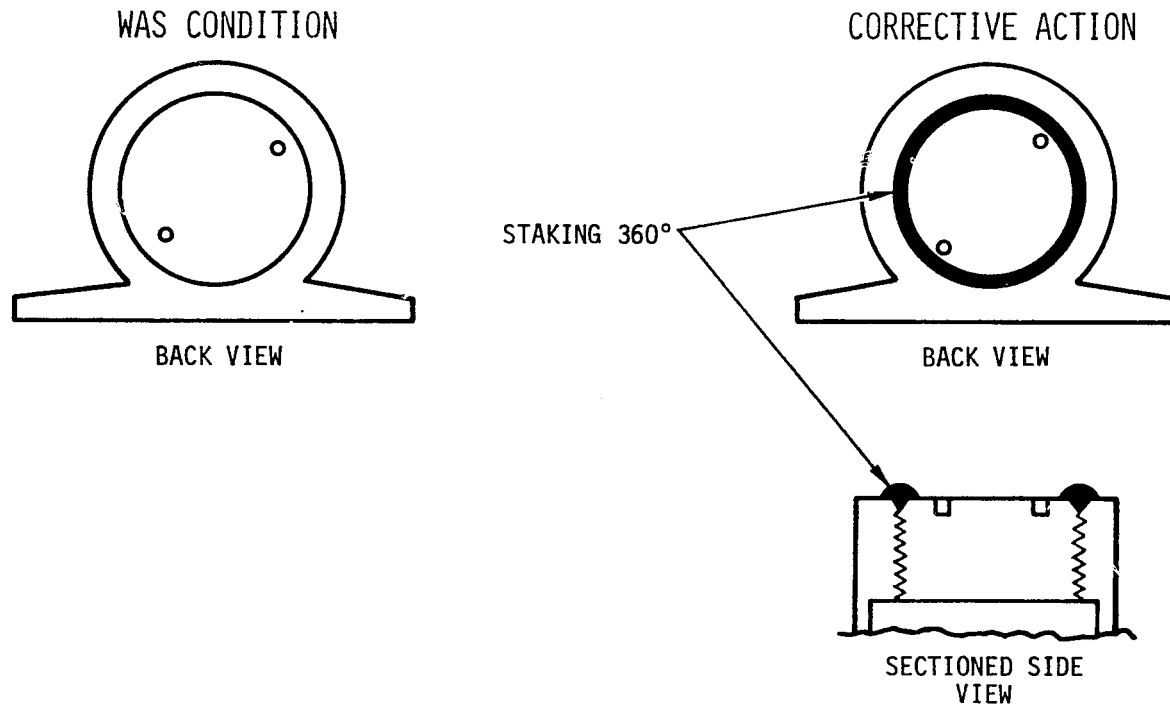
ATS-6 POWER AMPLIFIER VIBRATION TEST FAILURE

LOOSE COMPONENTS

CORRECTIVE ACTIONS

- RE-REVIEW POWER AMP SOLDER JOINTS & COMPONENTS FOR VIBRATION SENSITIVITY
- STAKE BOTH RF TERMINAL LOAD INSERTS

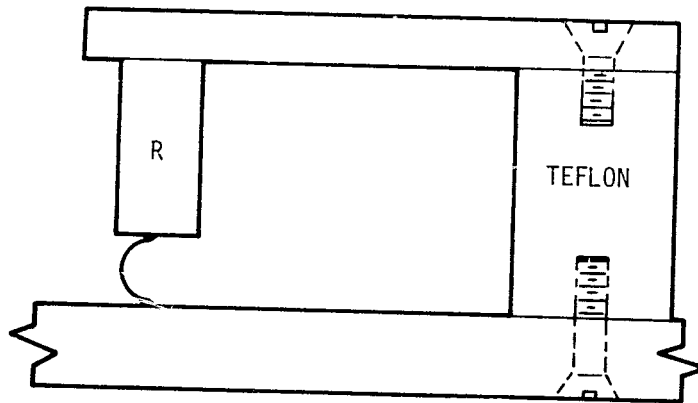
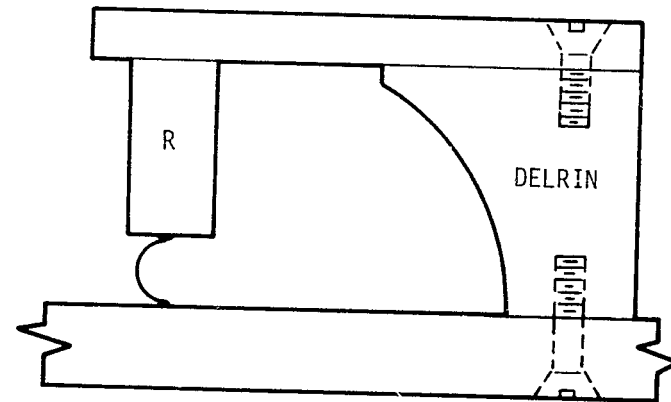
ATS-6 POWER AMPLIFIER VIBRATION TEST FAILURES

RESISTOR TERMINATION BLOCK

CORRECTIVE ACTIONS

- USE DELRIN WITH IMPROVED CROSS SECTION
- DIMENSIONALLY CONTROL HELICOIL INSERT
- STAKE MOUNTING SCREWS
- VERIFY BY OFF-LIMIT VIBRATION TESTING

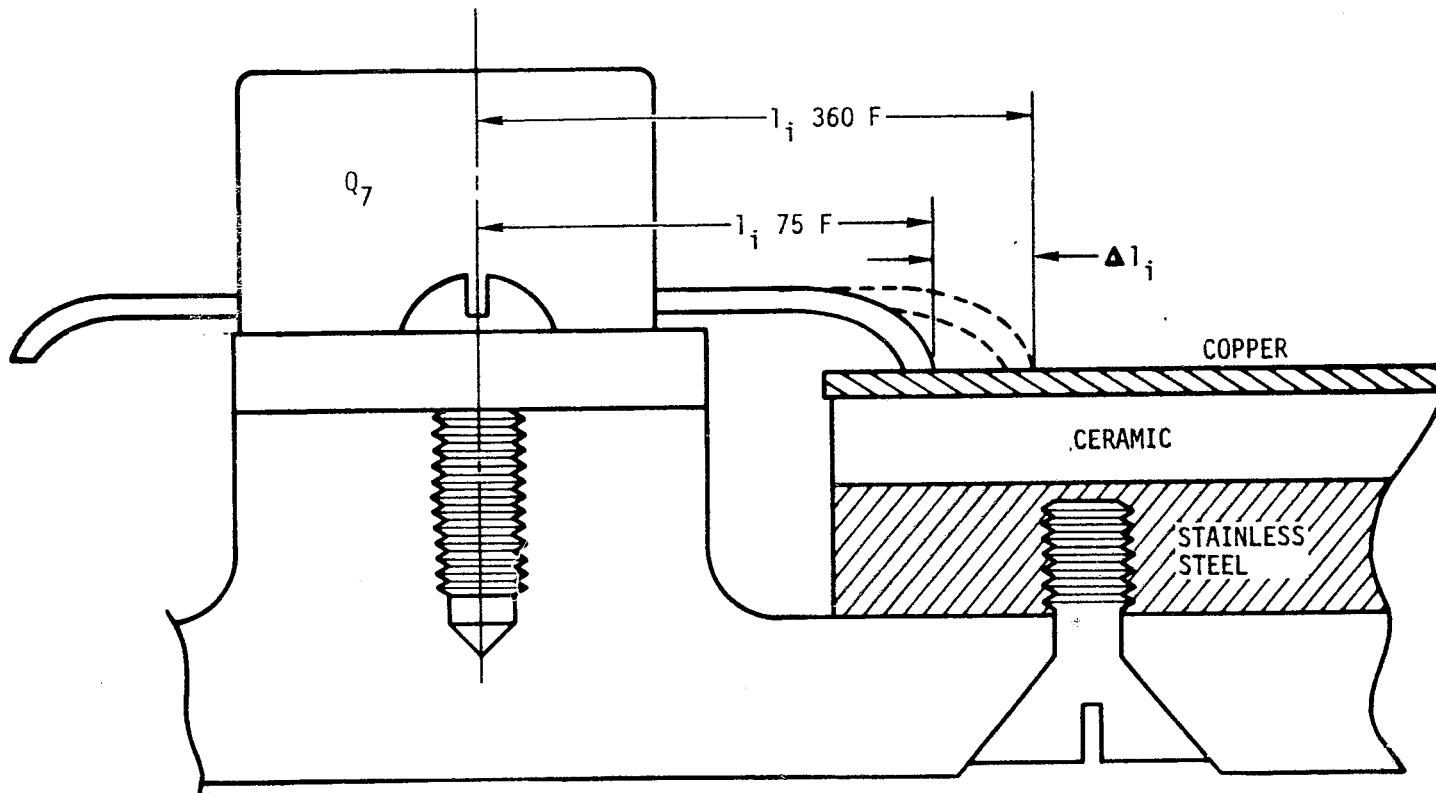
ATS-6 POWER AMPLIFIER BASIC TRANSISTOR INSTALLATION

- TEARDOWN INSPECTION REVEALED BROKEN SOLDER CONNECTION AT ONE BASIC AMPLIFIER MODULE (OUTPUT HYBRID)
- SOLDER JOINT 20 POWER INSPECTION REVEALED SEVERAL CRACKED JOINTS
- FLIGHT UNITS 20 POWER INSPECTED AND CRACKED JOINTS IDENTIFIED
- SOLDER JOINT STRESS ANALYSIS REVEALED MARGINAL JOINT CONFIGURATION WITH SAFETY FACTOR <1.0

- DEFINED NEW LOW STRESS SOLDERING PROCESS
- VERIFIED BY COMPARISON TESTING OF OLD AND NEW PROCEDURES
- POWER SUPPLY JOINTS FOUND ADEQUATE
- REVIEWED ALL SOLDER JOINTS
 - DESIGN ACCEPTABLE (LOW LEVEL AMPLIFIER & POWER SUPPLY)
 - RESOLDER (BASIC & INTERMEDIATE AMPLIFIER)

- TRIM, FORM, PRETIN, AND INSPECT COMPONENT LEADS FOR POSITIVE CONTACT TO TRACE
- FORM LEADS TO PROVIDE STRESS RELIEF
- INSTALL COMPONENTS WITH LOCATING PINS TO CENTER
- SOLDER ONE SIDE, AFTER COOLING LOOSEN MOUNTING SCREW AND ALLOW BUILT-IN STRESS TO RELIEVE TO ZERO
- TIGHTEN SCREW AND SOLDER OTHER SIDE - LOOSEN SCREW AND PERMIT LEAD STRESS TO EVENLY DISTRIBUTE TO BOTH LEADS
- TORQUE MOUNTING SCREW AFTER COOL DOWN
- ADDED HIGH TEMPERATURE STRESS RELIEF BY SOLDERING AT ELEVATED TEMPERATURE OF 43 DEG C

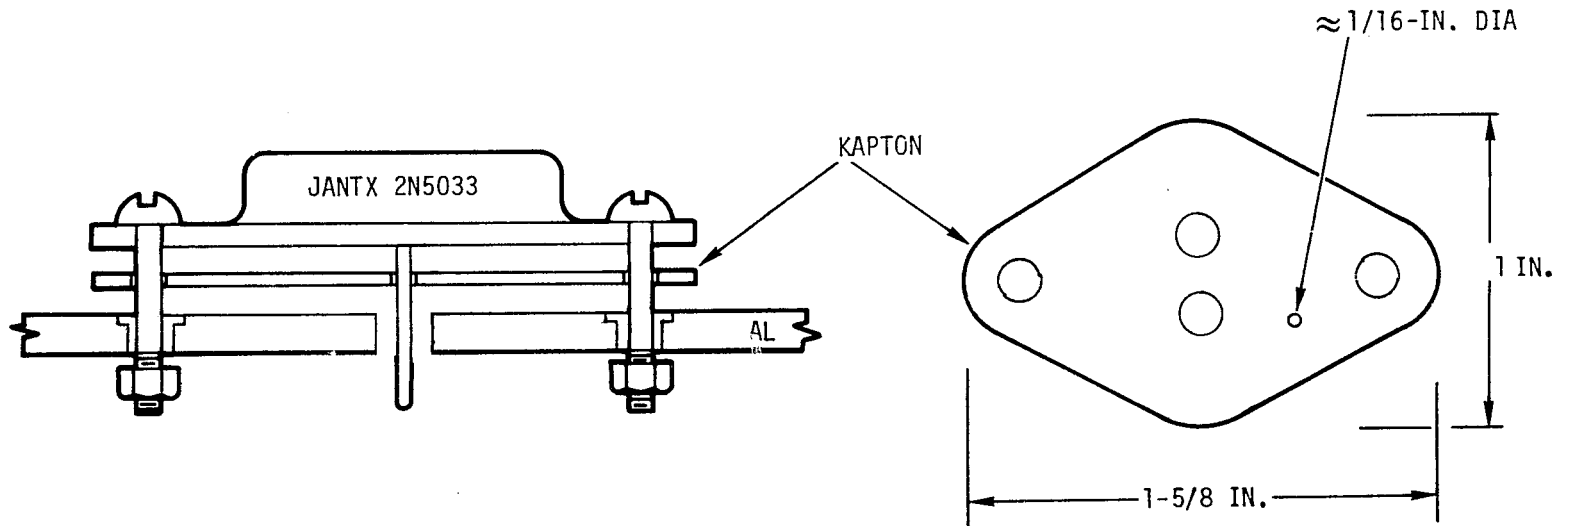
ATS POWER SUPPLY :
KAPTON HOLE

- FAULT IN THE POWER SUPPLY - THE POWER SWITCHING TRANSISTOR Q₆ COLLECTOR (CASE) WAS FOUND SHORTED TO CHASSIS WITH A CHARRED HOLE IN THE KAPTON 2 MIL INSULATOR AND ARC PITTING ON BOTH TRANSISTOR AND MOUNTING BRACKET SURFACES

- KAPTON SHORT CAUSED BY ARCING POTENTIAL DUE TO CHARGE POTENTIAL ON INPUT POWER LINES ACROSS HOLE IN KAPTON
- ARCING UNIQUE TO QUAL TEST SETUP
- CSM INSTALLATION GROUNDED - THEREFORE SATISFACTORY

- DESIGN FUNCTIONALLY ADEQUATE AND CONSERVATIVE
- DESIGN DEFICIENCIES CORRECTED
 - OUTPUT VOLTAGE TRANSIENT AT TURN-ON
 - MECHANICAL SENSITIVITY TO VIBRATION
- CONFIDENCE INCREASED BY POWER SUPPLY REBUILD PROGRAM
 - REBUILD THREE FLIGHT POWER SUPPLIES
 - REUSE ONLY INDUCTORS, TRANSFORMERS, AND INPUT FILTER AND BRACKET HARDWARE
 - ALL ELECTRONIC PARTS IDENTICAL TO INITIAL BUILD

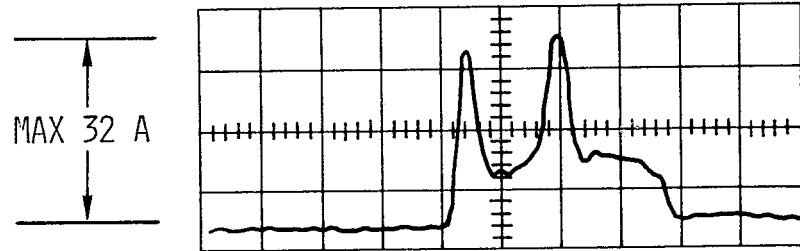
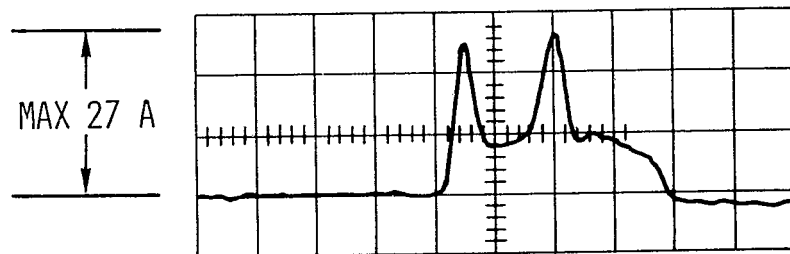
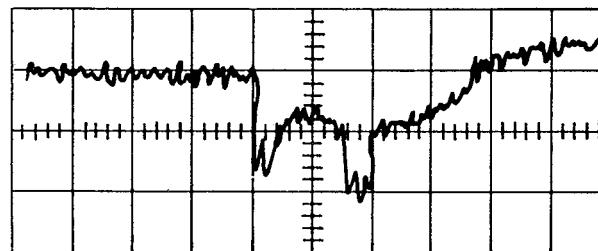
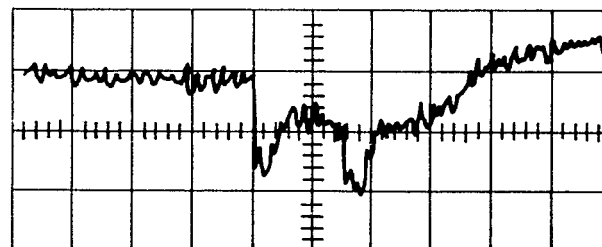
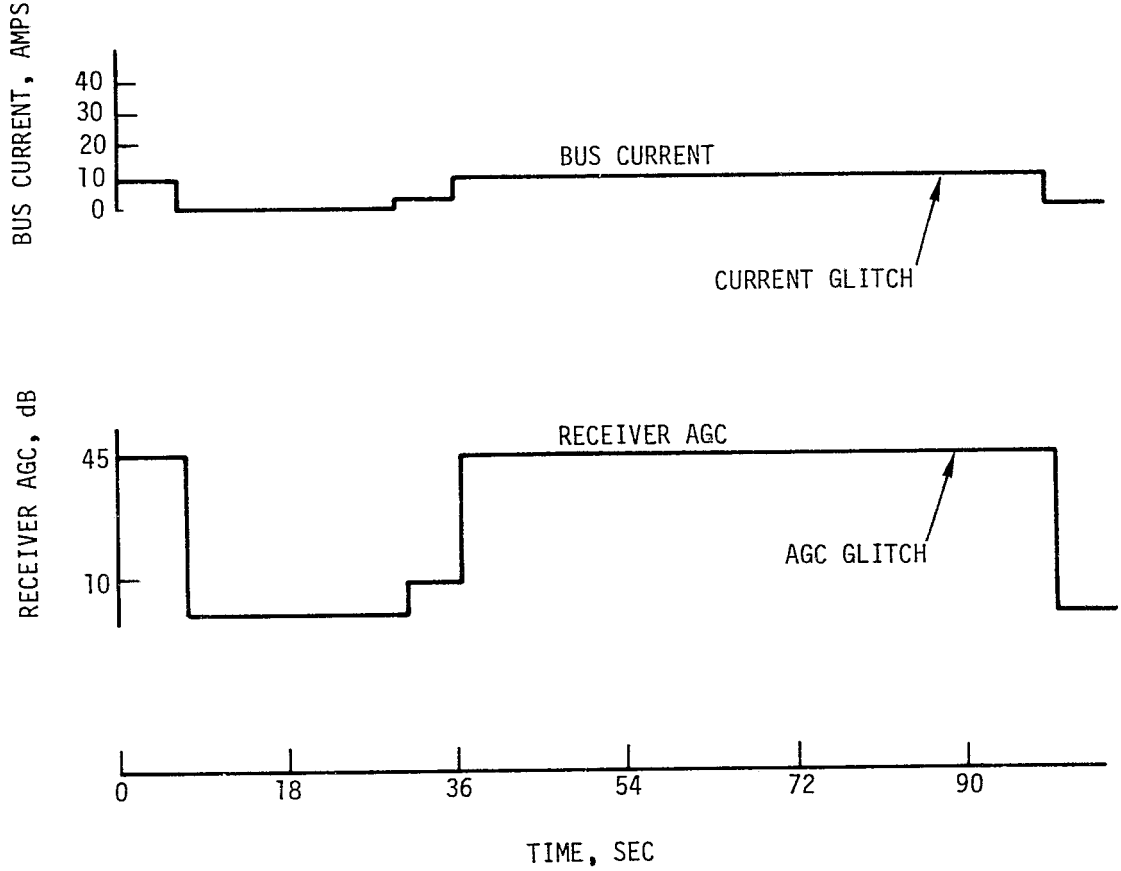
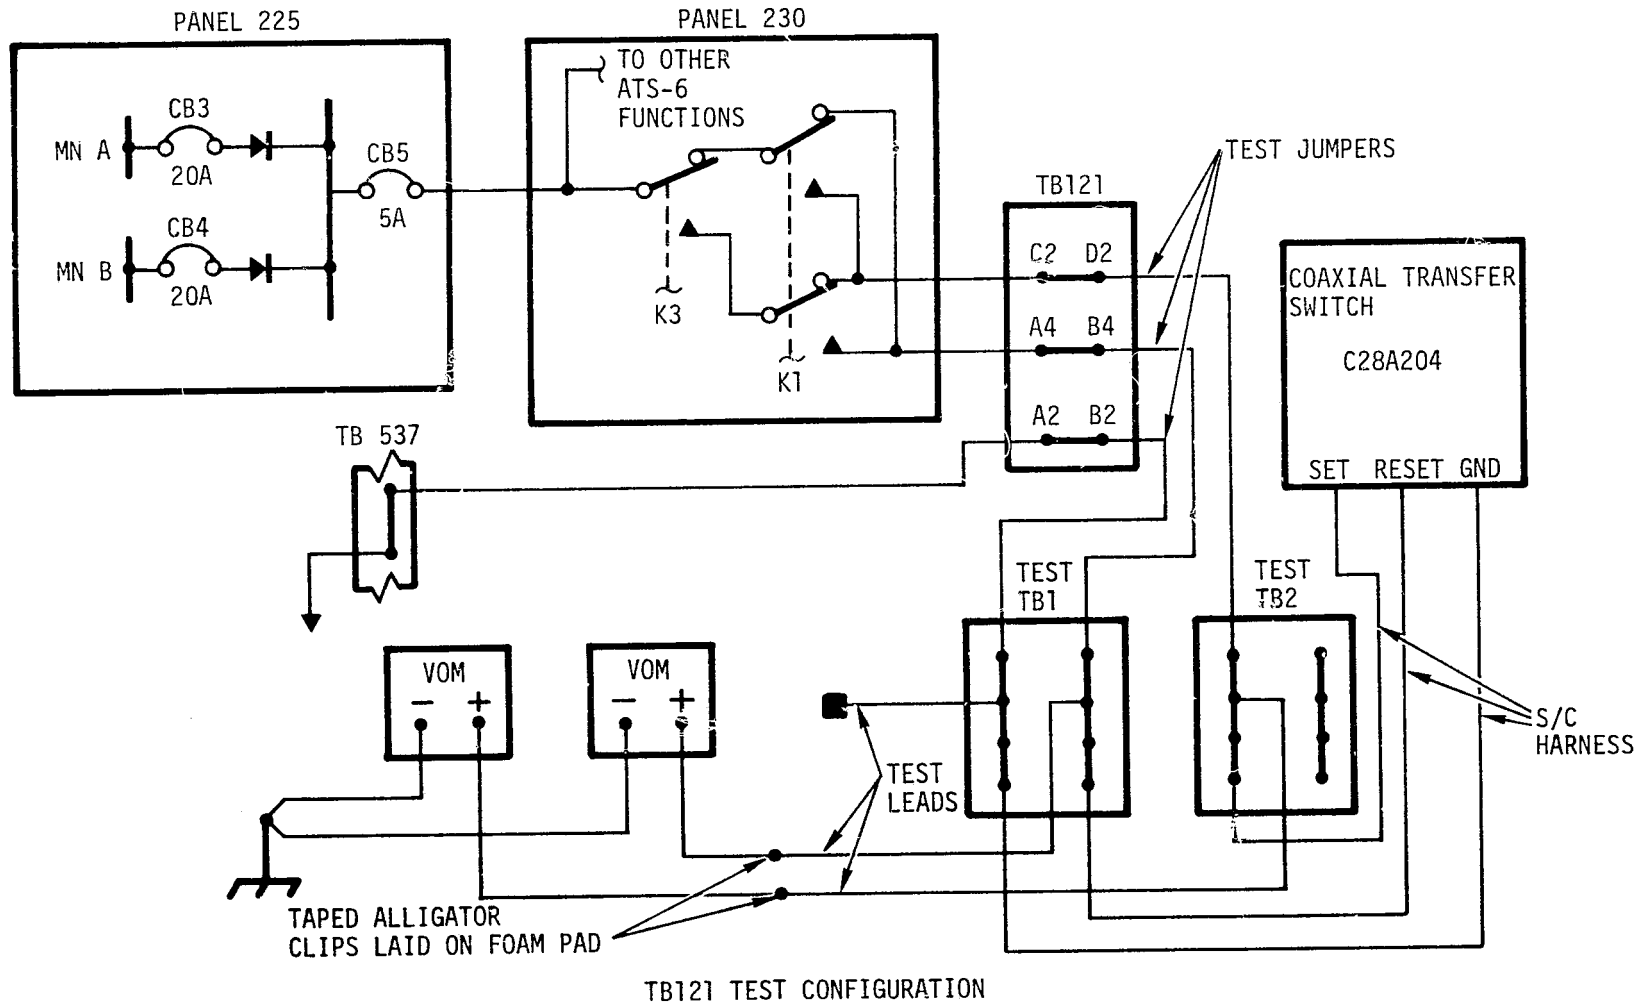
FRRID 111.2,8.2 (CONT)
MAIN BUS A AND B CURRENT GLITCHES

- UNABLE TO DETERMINE EXACT CAUSE OF CURRENT GLITCH
- MOST PROBABLE CAUSE IS FAILURE OF FILTER CAPACITOR IN ONE OF LOADS PREVIOUSLY IDENTIFIED
 - MOST LIKELY UNIT IS ATS-6 PA, SINCE GLITCH IN RECEIVER SIGNAL STRENGTH WAS NOTED AT SAME TIME AS CURRENT GLITCH
 - ANALYSIS OF PA SHOWED THAT MOST LIKELY FAILURE WAS FILTER CAPACITOR IN PA POWER SUPPLY
 - POWER SUPPLY CAPACITOR INSPECTION AND DISSECTION DID NOT SHOW EVIDENCE OF SHORT
 - IF PROBLEM WOULD OCCUR IN FLIGHT, SWITCH TO REDUNDANT PA

- ALL POWER SUPPLIES FOR FLIGHT PA'S WILL BE REPLACED WITH REBUILT UNITS

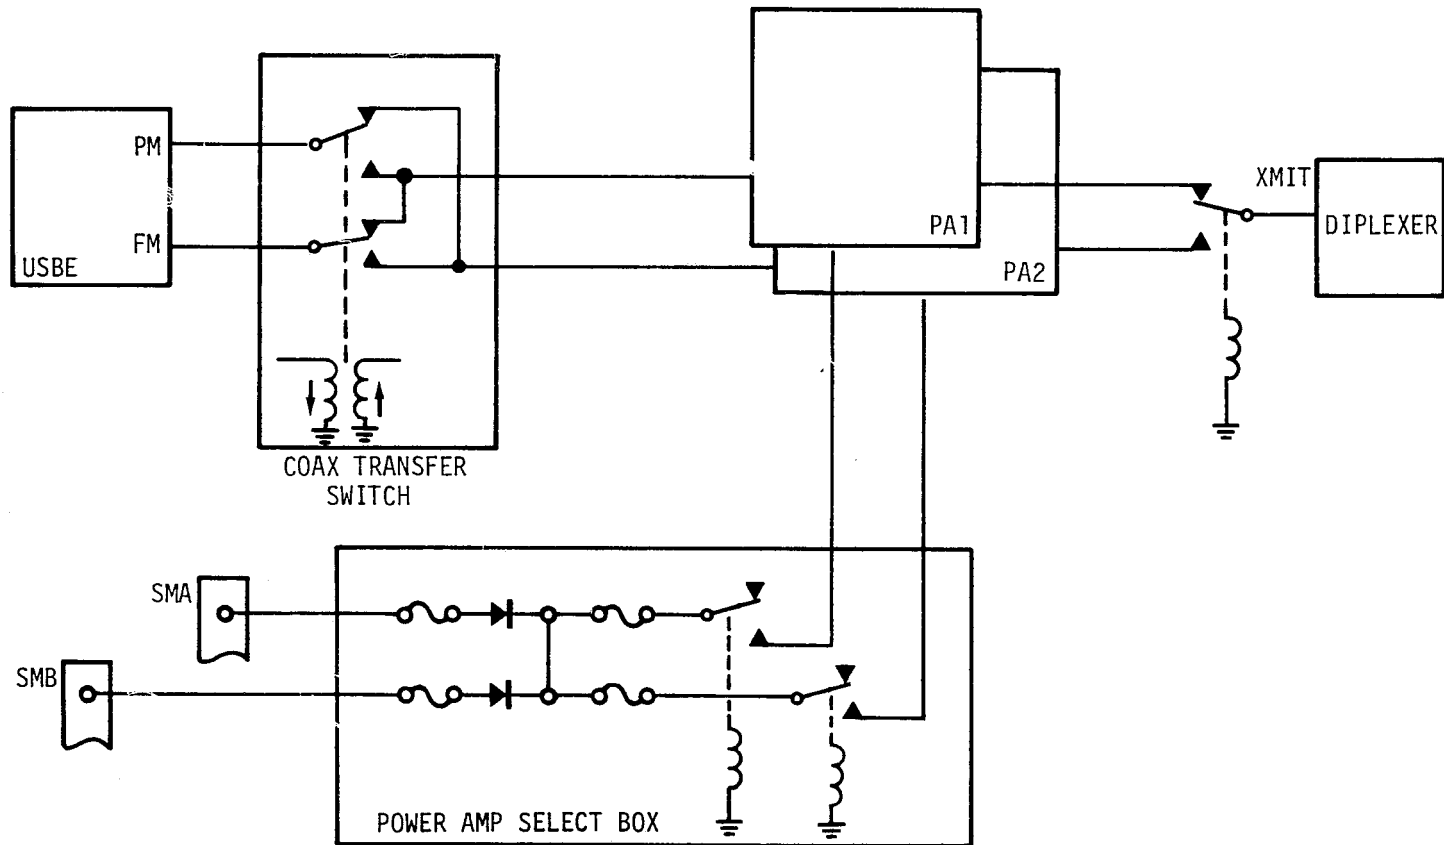
FRRID 111.2.11.2 (CONT)
ATS-6 POWER AMPLIFIER POWER OUTPUT

- ATS-6 S-BAND POWER AMPLIFIER DELAY IN COMING ON FOLLOWING APPLICATION OF DC POWER AND RF DRIVE (UNEXPLAINED ANOMALY)
 - BOTH PA'S EXPERIENCED PROBLEM
 - 8 IDENTIFIED OCCURRENCES, PA NO. 1
 - 3 IDENTIFIED OCCURRENCES, PA NO. 2
 - RF OUTPUT APPROX. 35 dB BELOW NORMAL AND DC CURRENT 1 TO 2 AMPS VS 10 AMPS NORMAL
 - PROBLEM OCCURRED IN PM MODE ONLY
 - SELF-CLEARED, WITHIN APPROX. ONE MINUTE, OR WAS CLEARED BY SWITCHING TO OTHER AMPLIFIER (OR OFF) MOMENTARILY OR BY SWITCHING TO FM DRIVE

- INITIAL CIRCUIT ANALYSIS AND DATA REVIEW SUGGESTED THE FOLLOWING POSSIBLE CAUSES:
 - HANGUP IN COAX TRANSFER SWITCH
 - HANGUP IN RELAY K-1 IN PANEL 230
 - FAULTY POWER CONTROL RELAYS IN TRANSMITTER SELECT BOX
 - PROBLEM WITHIN THE POWER AMP ITSELF
- COAX TRANSFER SWITCH REPLACED
 - PROBLEM RECURRED WITH NEW TRANSFER SWITCH
- INSTALLED VOM'S TO MONITOR COMMANDS TO COAX TRANSFER SWITCH
 - PROBLEM RECURRED WITH NORMAL COMMANDS
- INSTRUMENTED INPUT DC POWER, INPUT AND OUTPUT RF POWER OF EACH PA
 - PROBLEM RECURRED WITH INPUT DC OK, INPUT RF POWER OK
- INTERMITTENT COAX CONNECTOR FOUND AND REPAIRED (PM RF TRANSFER SWITCH COAX CABLE)
 - HANGUP NEVER AGAIN OCCURRED
 - COAX WOULD NOT EXPLAIN PROBLEM SINCE HANGUP OCCURRED WITH PROPER RF DRIVE
