DANIEL ON THE MOON

TECHNICAL ASPECTS PART 2

TESTING FLIGHT HARDWARE BEFORE MISSIONS

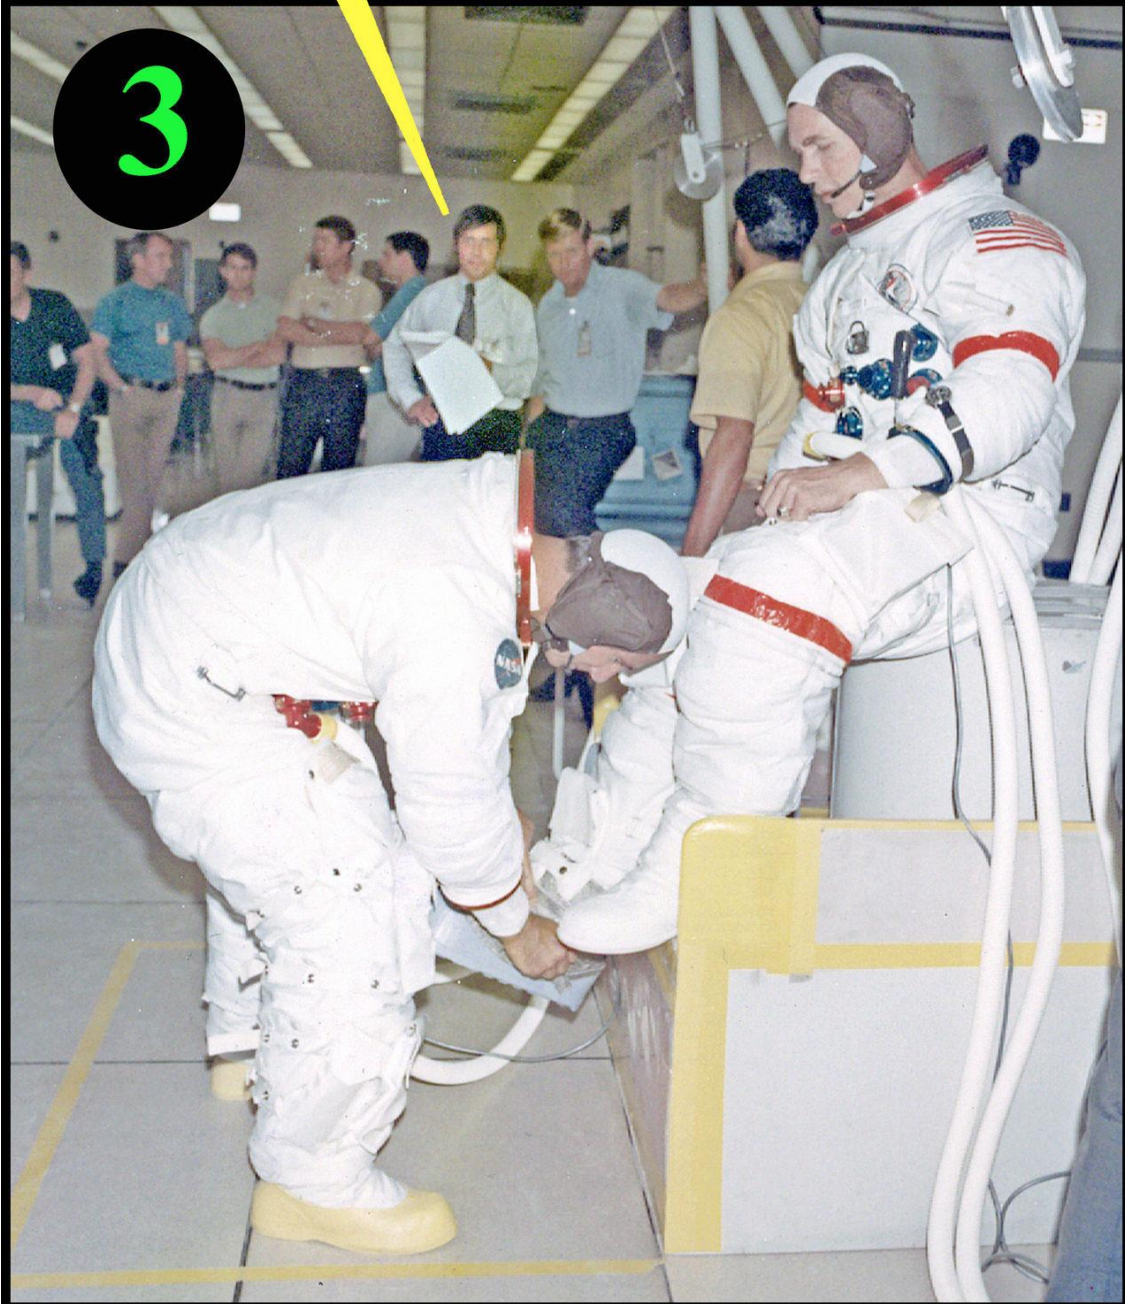
**JIM IRWIN & DAVE SCOTT USING
THE EVA PREP & POST PLATFORM
THAT WE HAD BUILT AT KSC
I'M FOLLOWING THE PREP & POST
PROCEDURES STEP BY STEP**

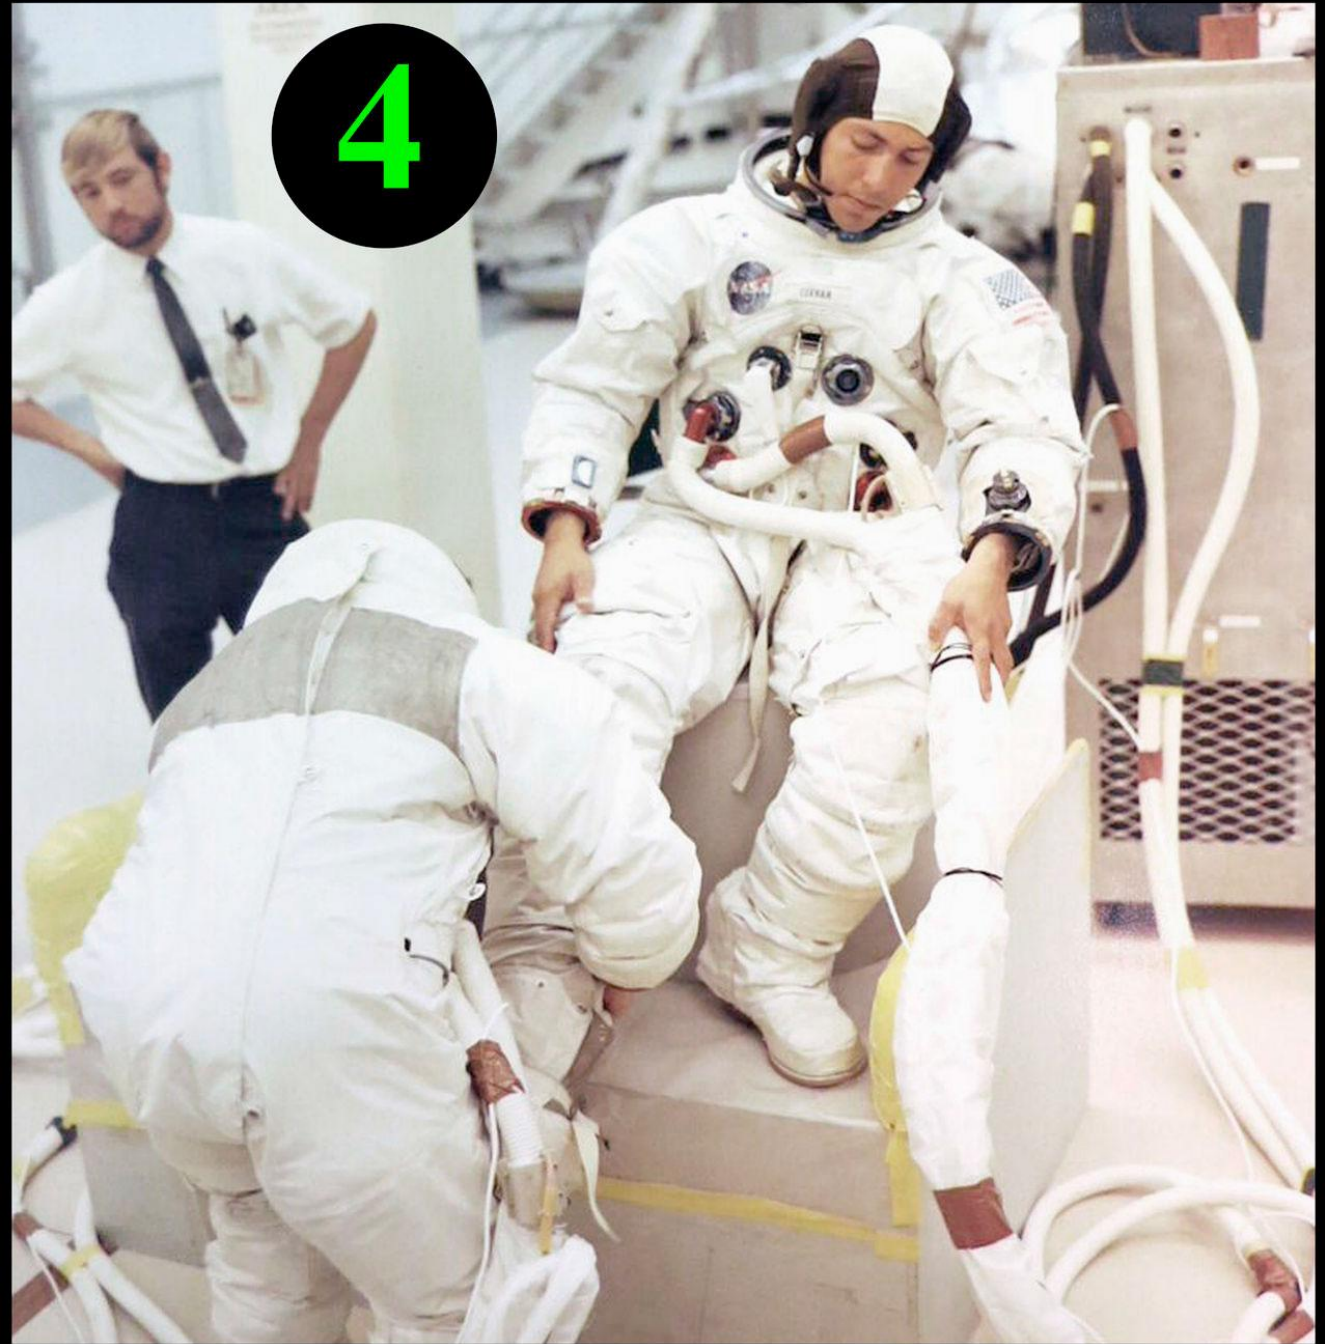
Photo #4 shows myself and a NASA Suit Engineer going through the same prep and post procedures that the astronauts had previously completed on, of course, the "platform". Our objective (myself and my fellow

"wannabe" astronaut) was to evaluate incorporated approved procedural and/or hardware modifications for validation. If validated, they would be permanently incorporated into the applicable NASA document.

ME AND A NASA ENGINEER USING THE EVA PREP & POST PLATFORM THAT WE HAD BUILT AT KSC

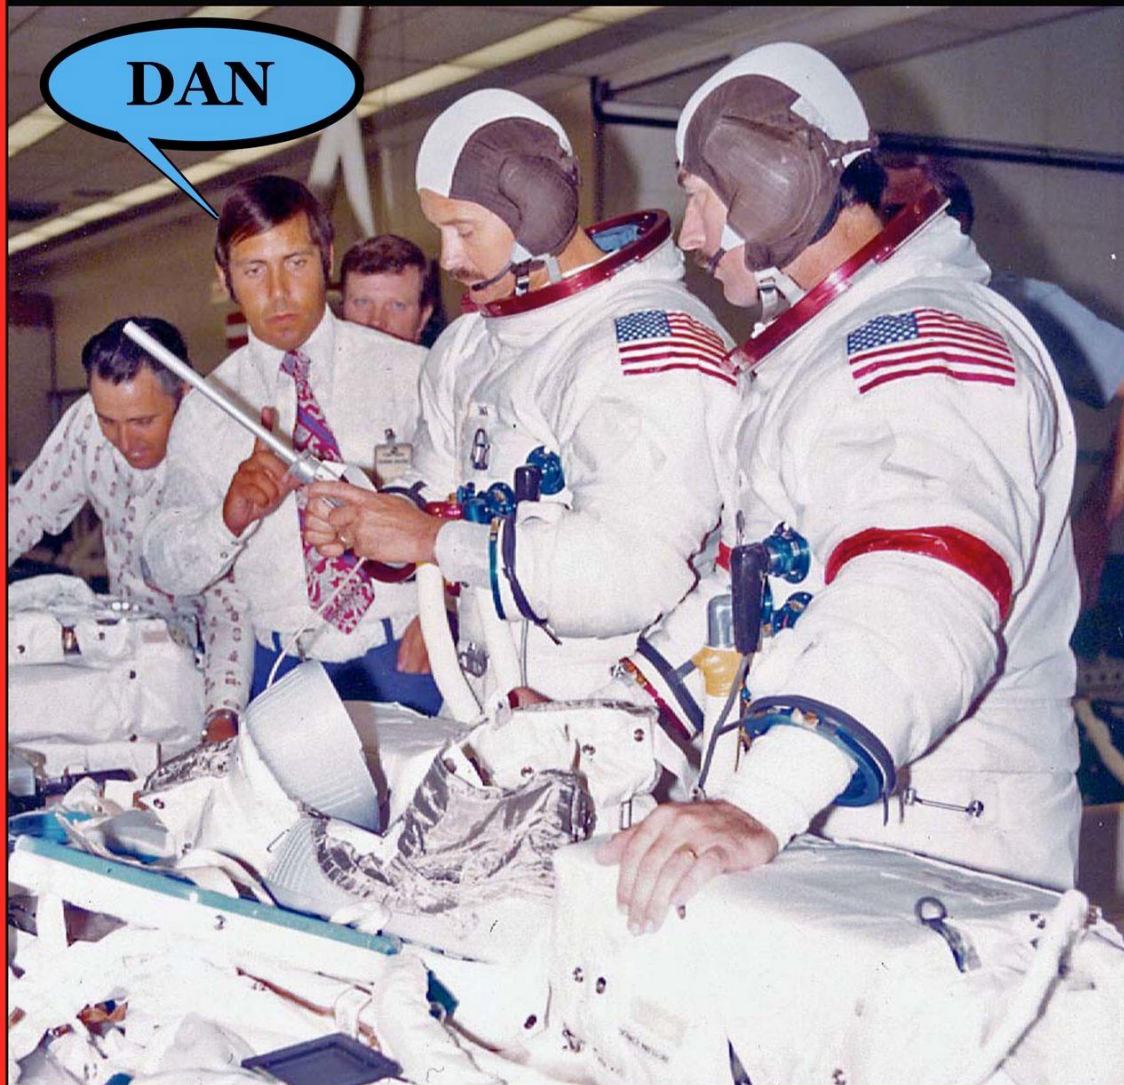
PRESENTING AND DEMONSTRATING THE NEW SPARE OPS ANTENNA (ADDED FOR APOLLO 17) TO APOLLO 17 BACKUP CREW YOUNG & DUKE

During both Apollo 15 and Apollo 16 EVAs, problems with Oxygen Purge System (OPS) antennas being broken, nicked and/or both were documented.

As a result of the Apollo 15 antenna problems, it was decided to modify the OPS thermal cover with the antenna completely covered (with the exception of the antenna tip) so that it was protected as much as possible from accidental damage while stowed and manipulated in the LM. To that end, two additional flaps were added to the OPS cover.

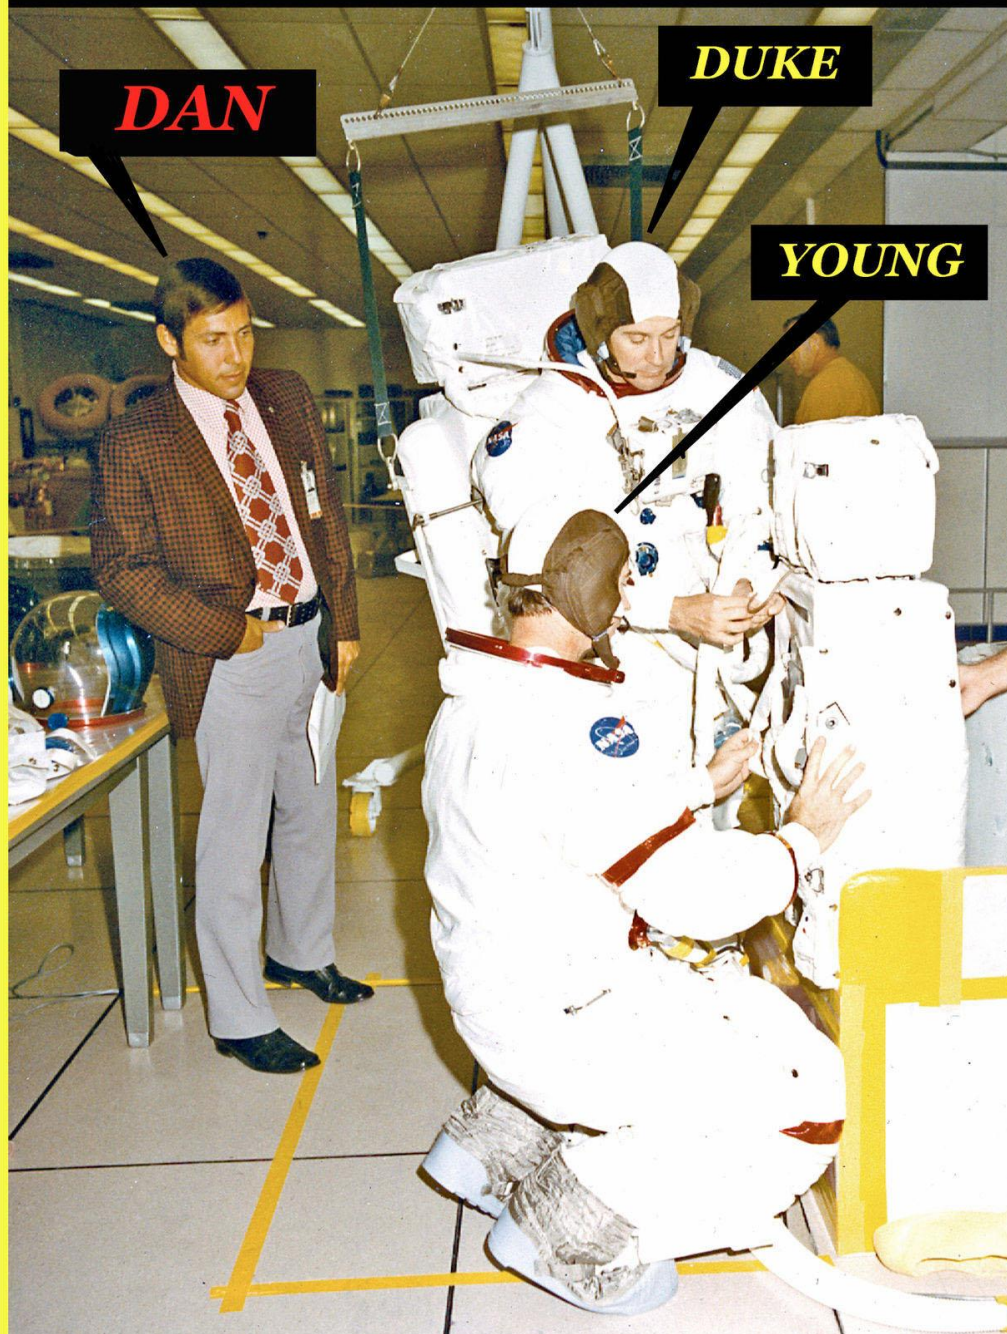
*DAN IS EVALUATING
ASTRONAUT JOHN
YOUNG'S ABILITY TO
"UNSTOW THE PLSS
HARNESSES" PRIOR TO
EVA.*

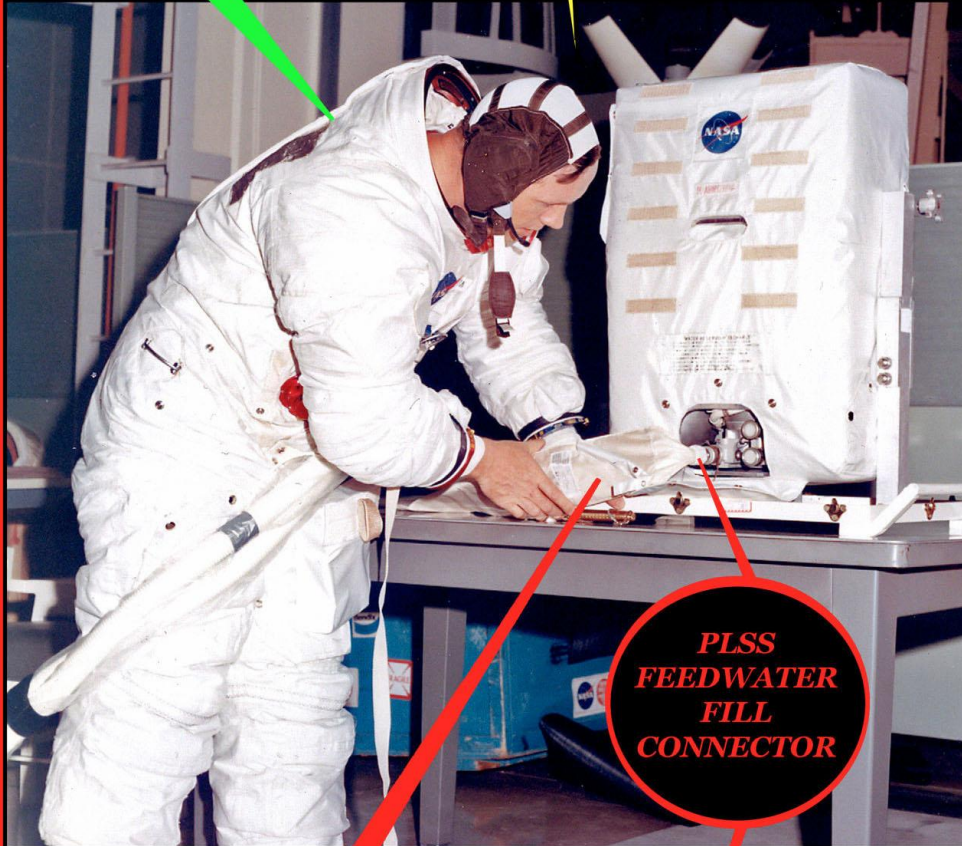
**FEEDWATER COLLECTION
PROCEDURE (BELOW) REFERRED
TO IN MY ABOVE "LM-5 CREW
TRAINING EXERCISES" MEMO**

**APOLLO 11 CDR
ARMSTRONG**

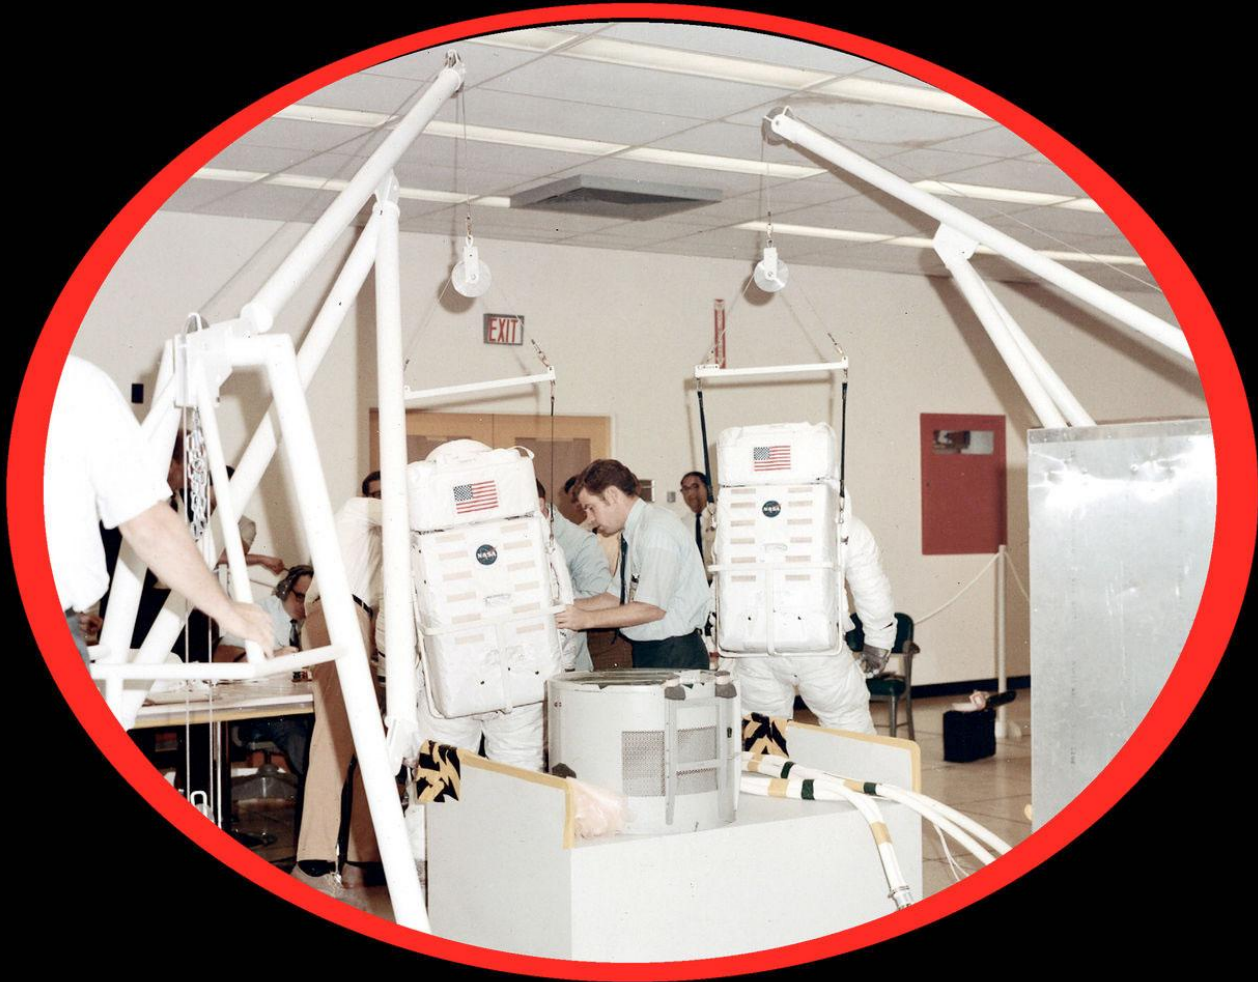
PLSS 1/6 "G" **"COUNTERBALANCES"**

**BEING USED DURING LM EVA PREP
AND POST PROCEDURES**

Before astronaut EVA crew training was assigned to KSC, there were reported problems in accurately determining the custom fixed lengths for the PLSS (Portable Life Support System) backpack harnesses (straps) that connected and secured the PLSS to the PGA (spacesuit Pressure Garment Assembly). Note that the PLSS harness lengths were custom sized for each astronaut.

The reported problem was that the sizing process did not take into account the heavier Earth weight of the PLSS/OPS at 125 lbs. vs. the 1/6 "G" lunar weight at 20.8 lbs. resulting in the Earth weight PLSS/OPS mockups and flight PLSS/OPSs when worn during crew fit and function testing and PLSS/OPS donning and doffing procedures resting lower on the astronaut's back than on the lunar surface.

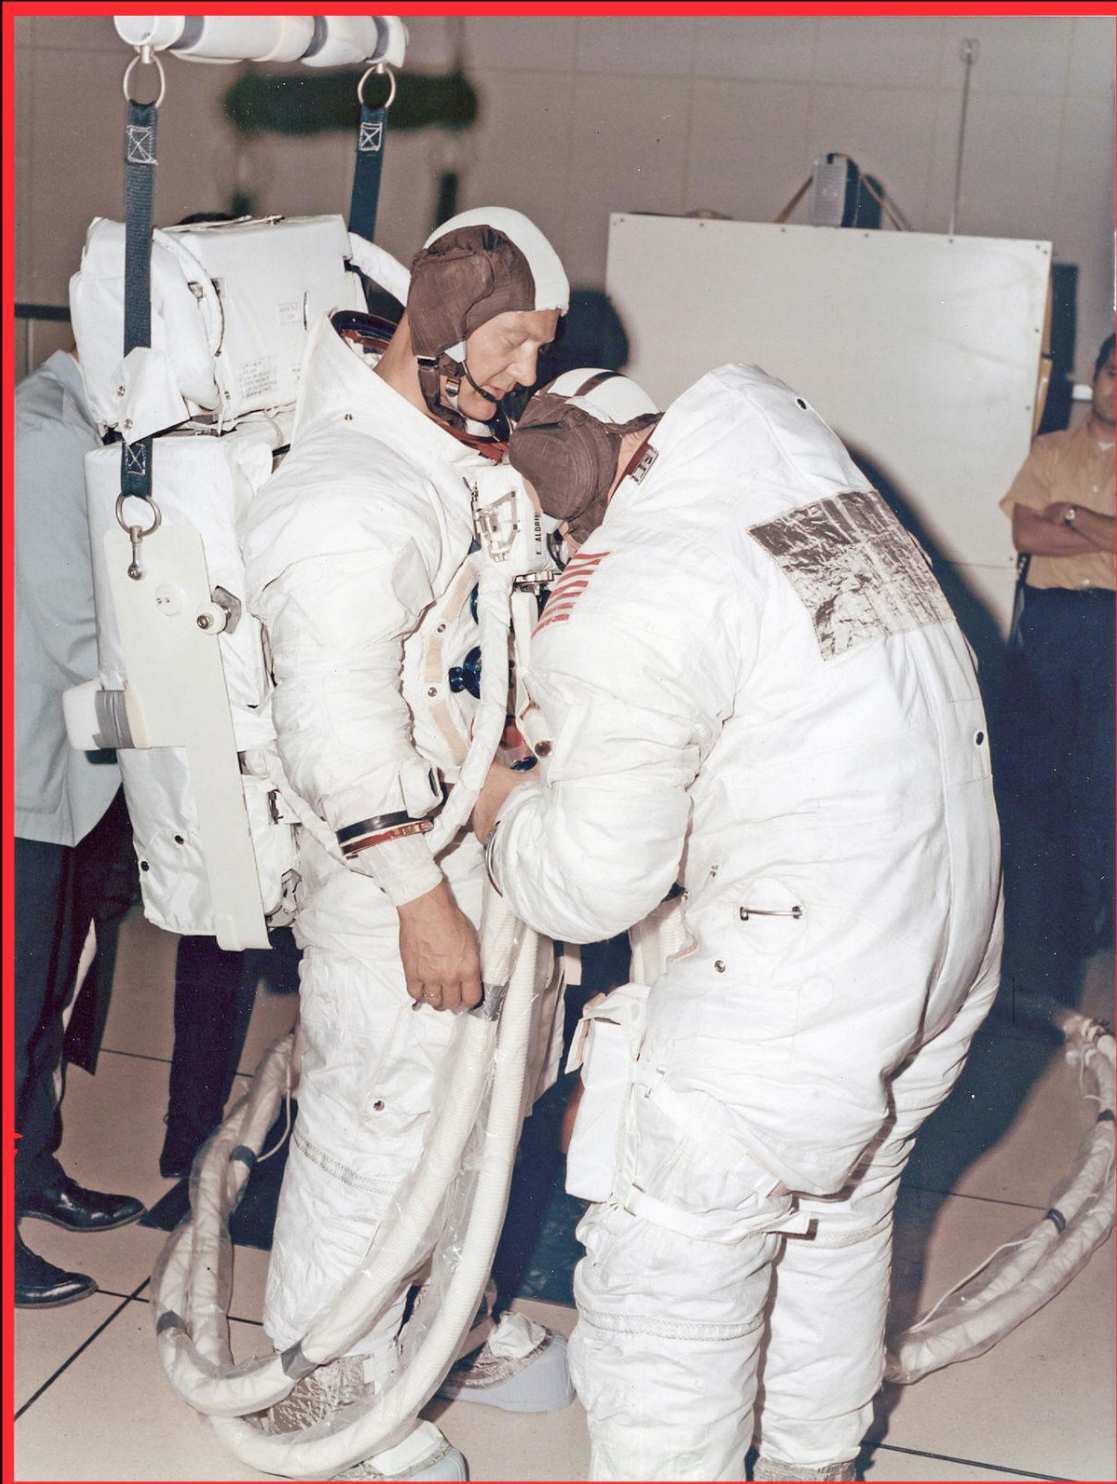
**“BUZZ” ALDRIN WITH
PLSS/OPS MOUNTED IN
“COUNTERBALANCE”
CRADLE**

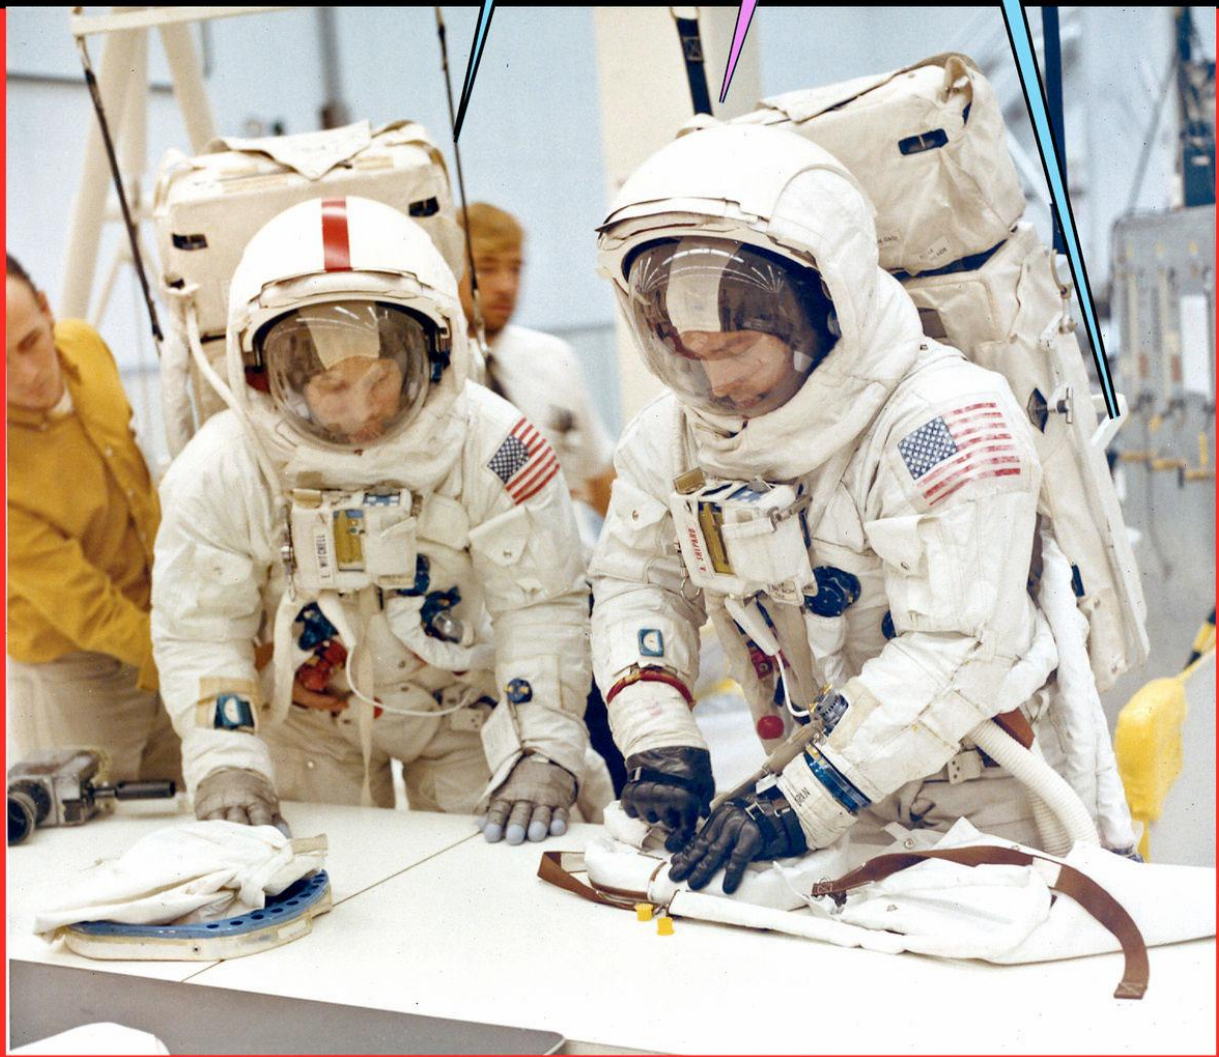
**DAN WITH PLSS/OPS
MOUNTED IN
“COUNTERBALANCE”
CRADLE**

**“COUNTERBALANCE”
CRADLES**

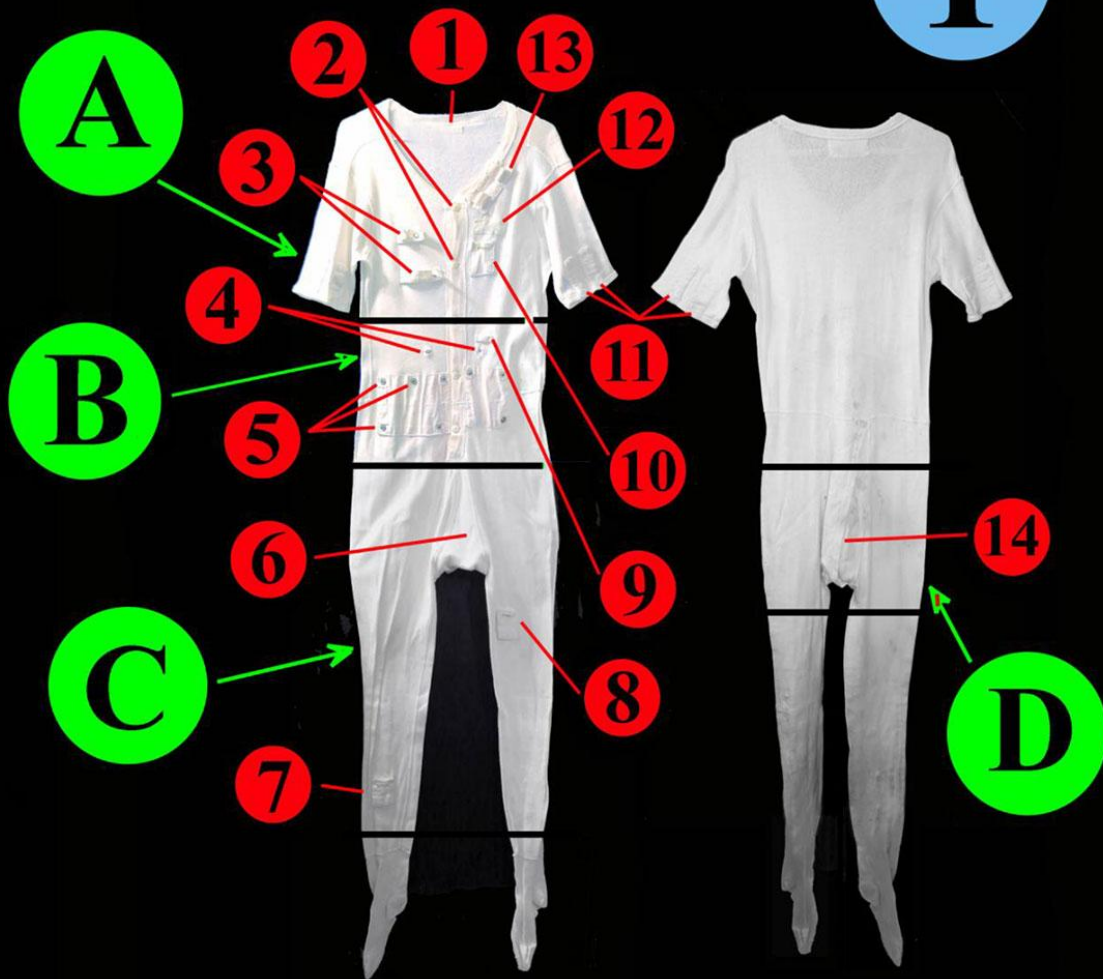
CONSTANT WEAR GARMENT (CWG)

Figure 1 shows the Constant Wear Garment (CWG) Feature Identifications 1-14. Below is a description of the Figure 1 numbered features:

The Constant Wear Garment (CWG) is a one-piece cotton undergarment that is worn next to the skin and encompasses the entire body exclusive of the head and hands. It is worn during intervehicular (IV) command module operations for general comfort, to absorb perspiration, and to hold the biomedical instrumentation system.

It absorbs excessive body moisture and prevents the crewman's skin from becoming chafed by the pressure garment assembly. The CWG is donned and doffed through the front opening, which is kept closed by five buttons. The feet are covered by socks sewn to the legs of the CWG.

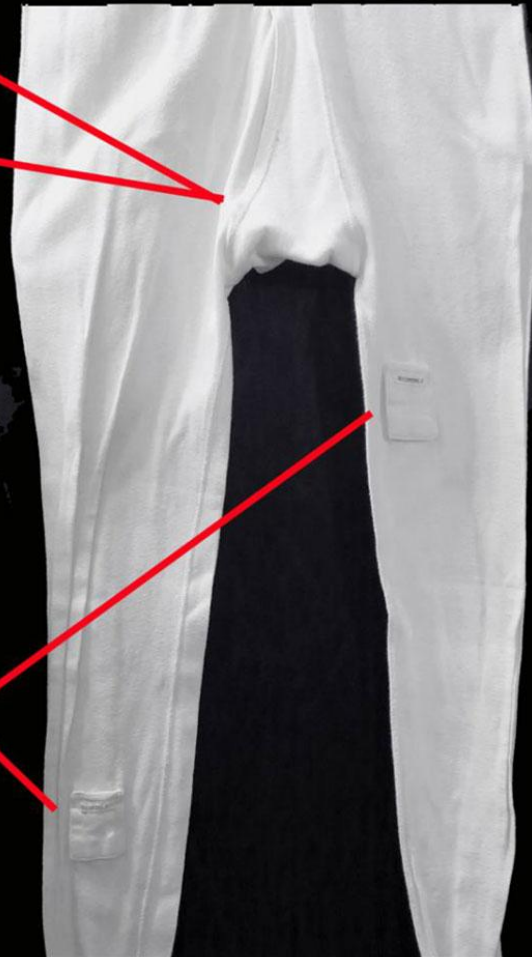
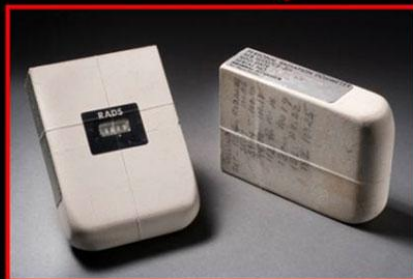
OPENING FOR
URINATION

DOSIMETER

Figure 4 shows in detail the features of the constant wear garment bottom section.

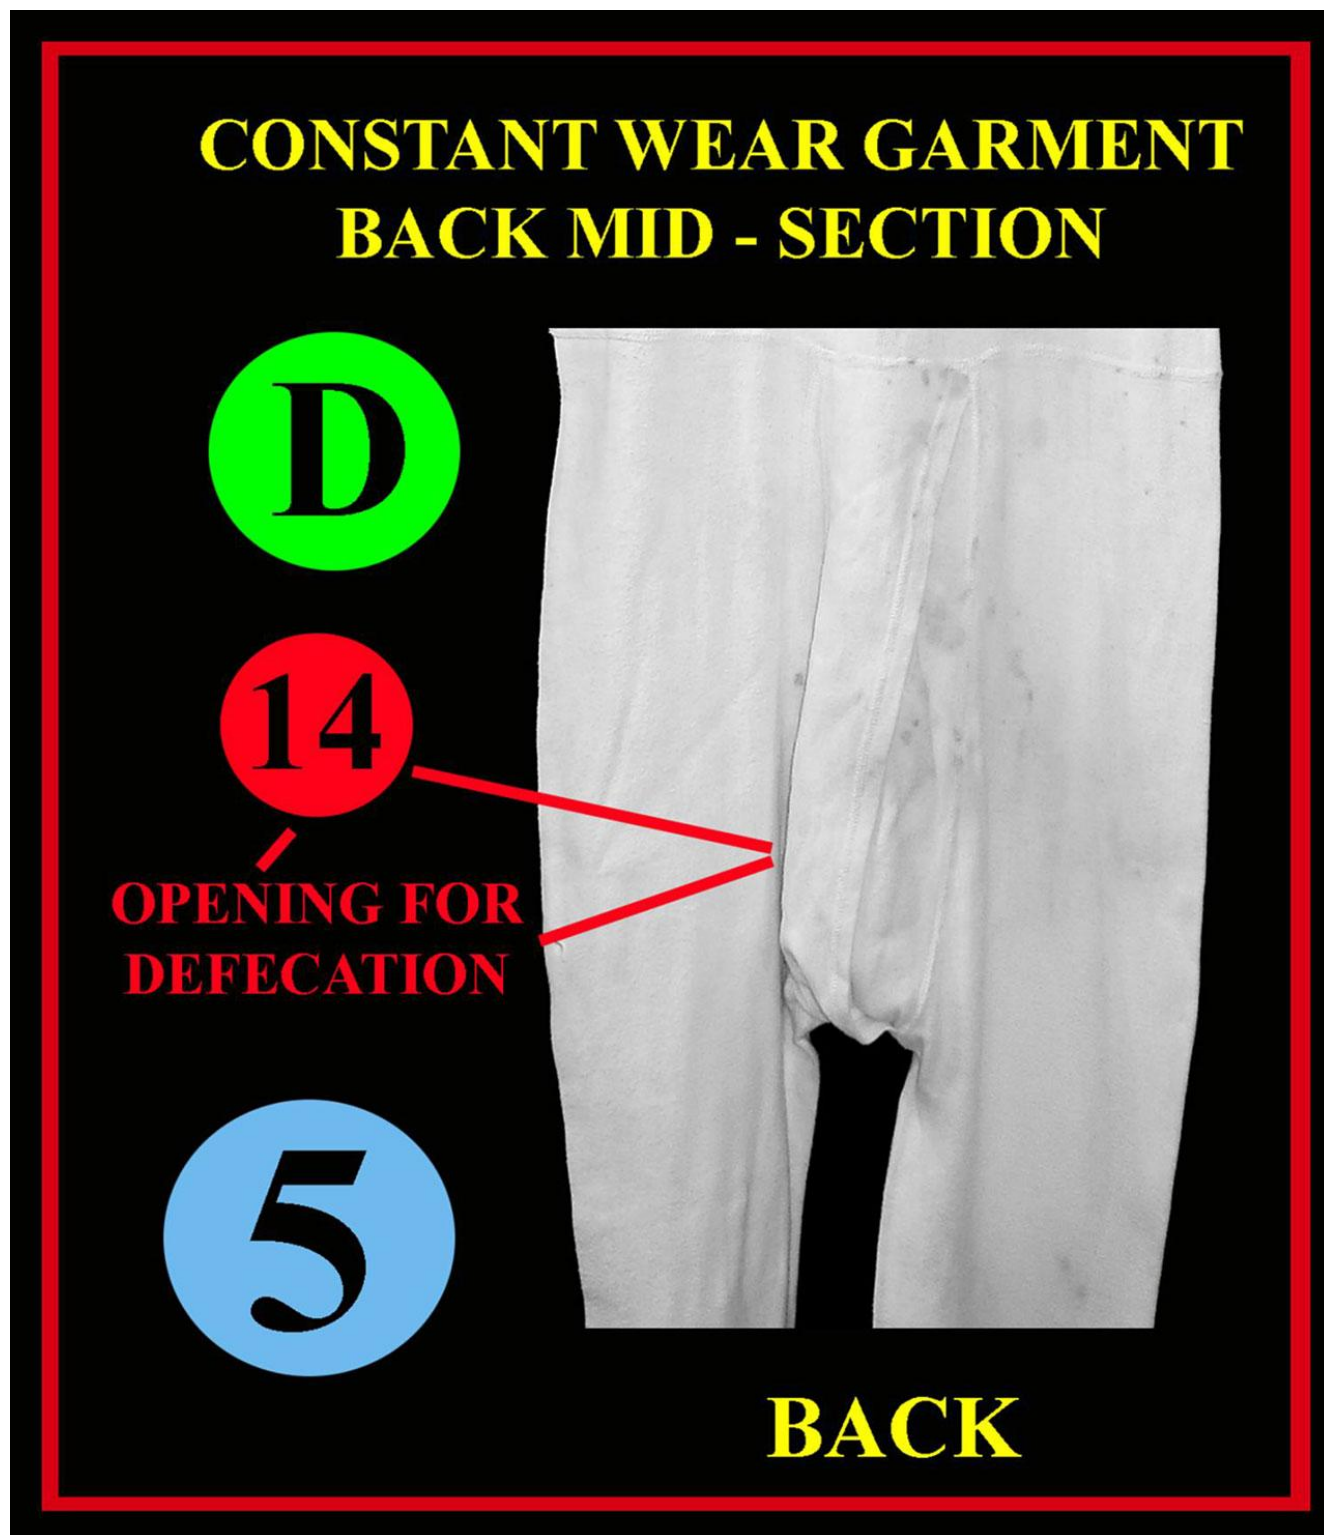
Figure 5 shows the back of the constant wear garment with feature 14 (opening for defecation).

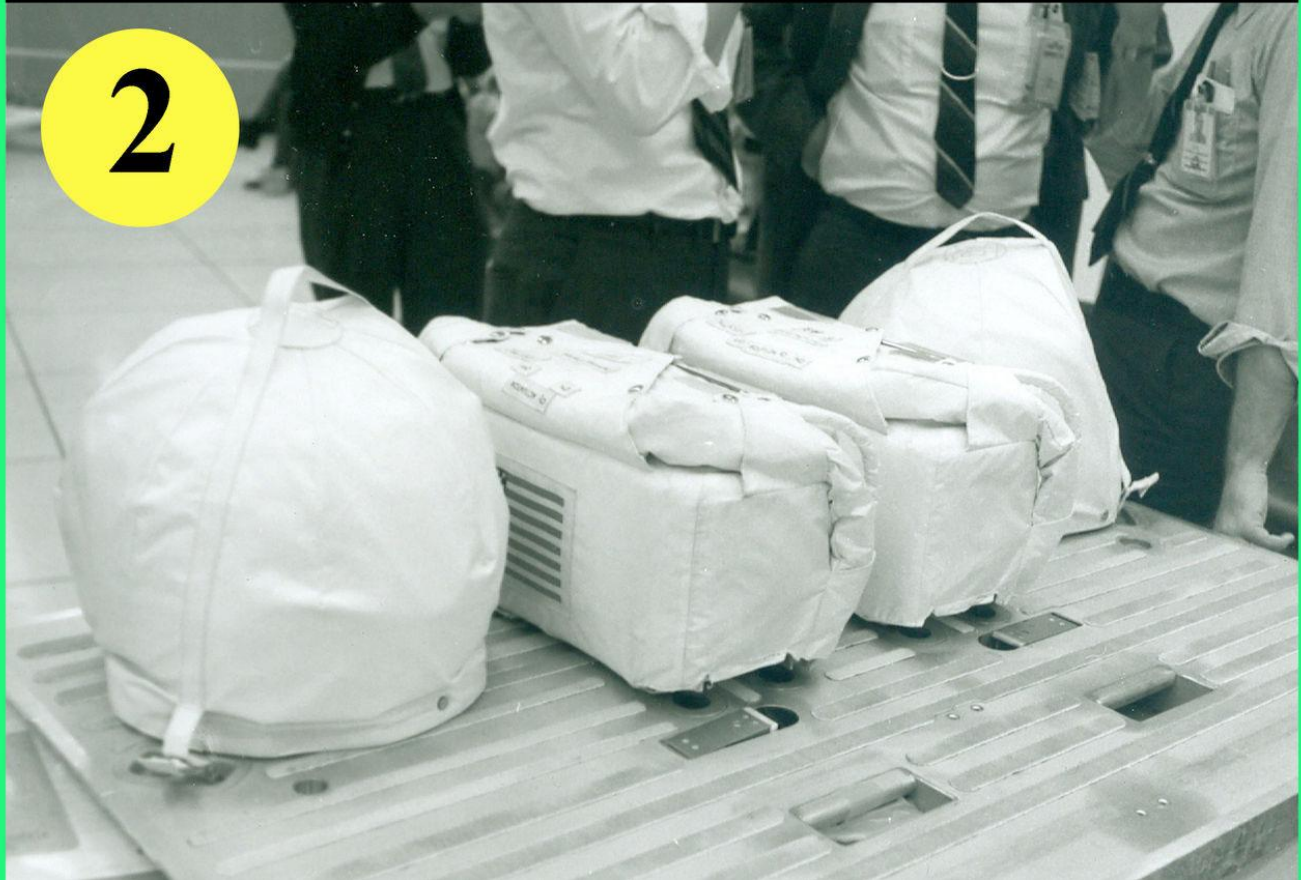
***OPS'S STOWED ON
LM FLOOR FOR
"LUNAR LAUNCH"***

A very important mission requirement was hardware interface fit checks to verify hardware compatibility between different contractors. Photos 1 and 2 below represent an "interface fit check" between Hamilton Standard's Oxygen Purge System (OPS) and Grumman's lunar module (LM) floor. Also, between ILC's helmet stowage bags and Grumman's LM floor.

The first objective of the fit check was to give the Apollo commander and lunar module pilot (in this case, Apollo 13 CDR Lovell and LMP Haise) the opportunity to install both OPSs to the LM floor (Photo 1). The second objective was to confirm compatibility of the OPS mounting feet and locking pin with the LM floor.

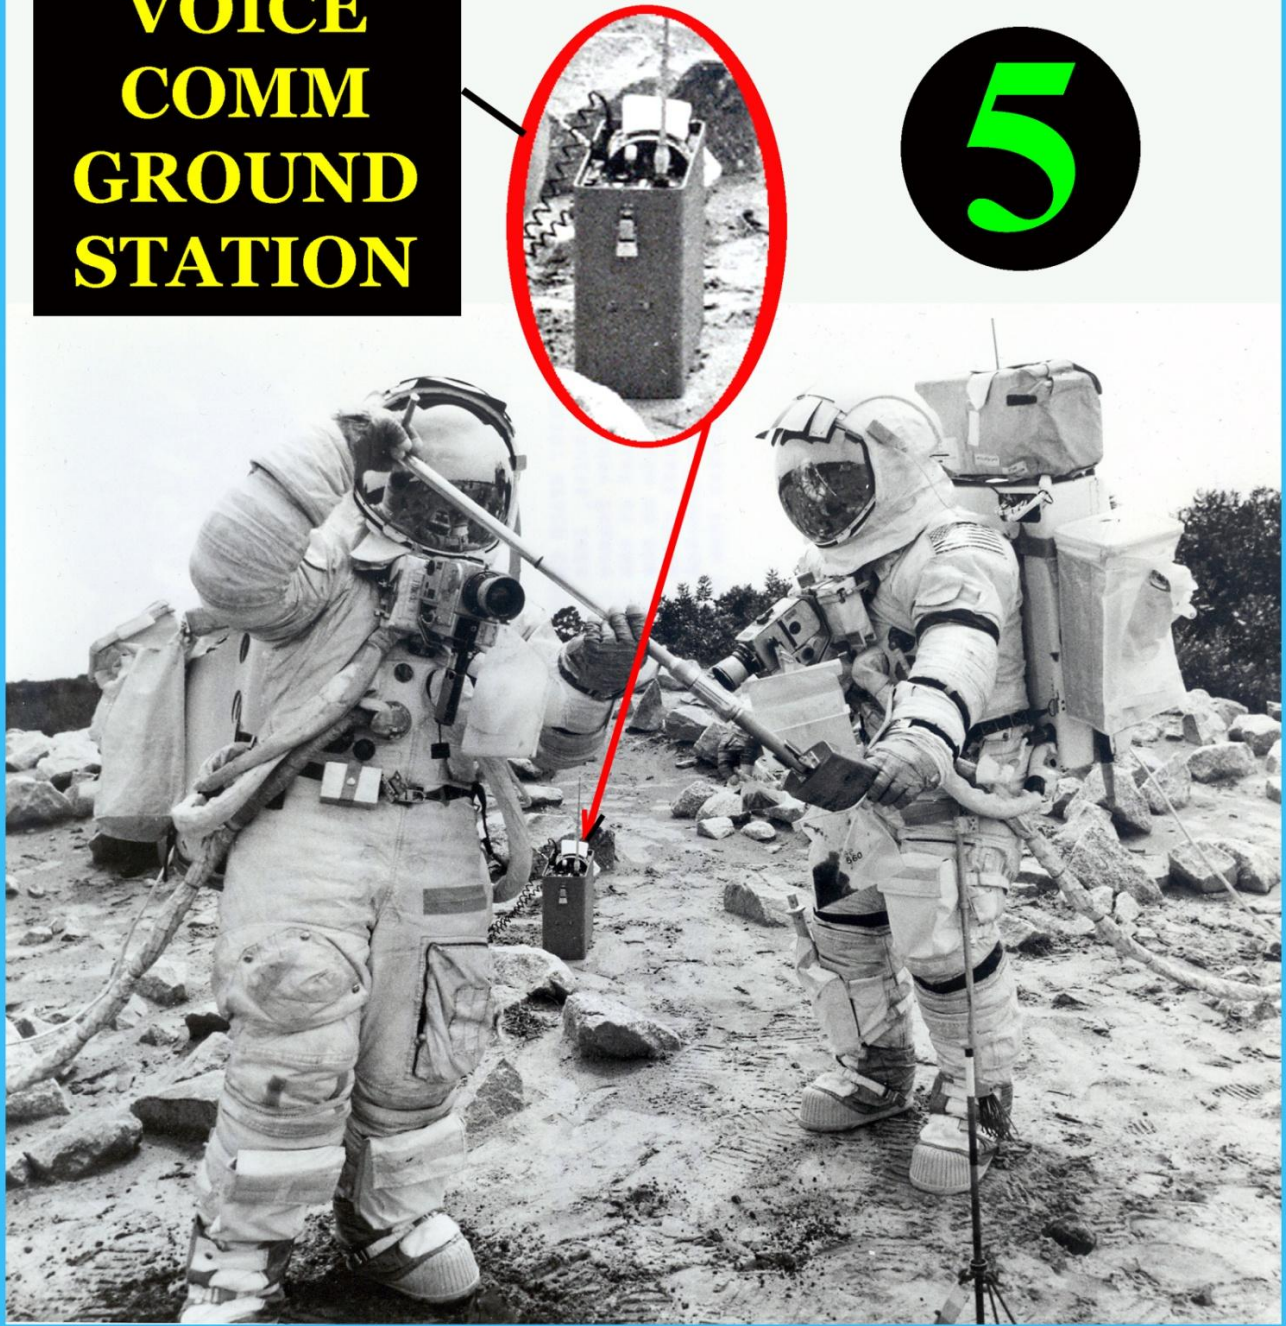
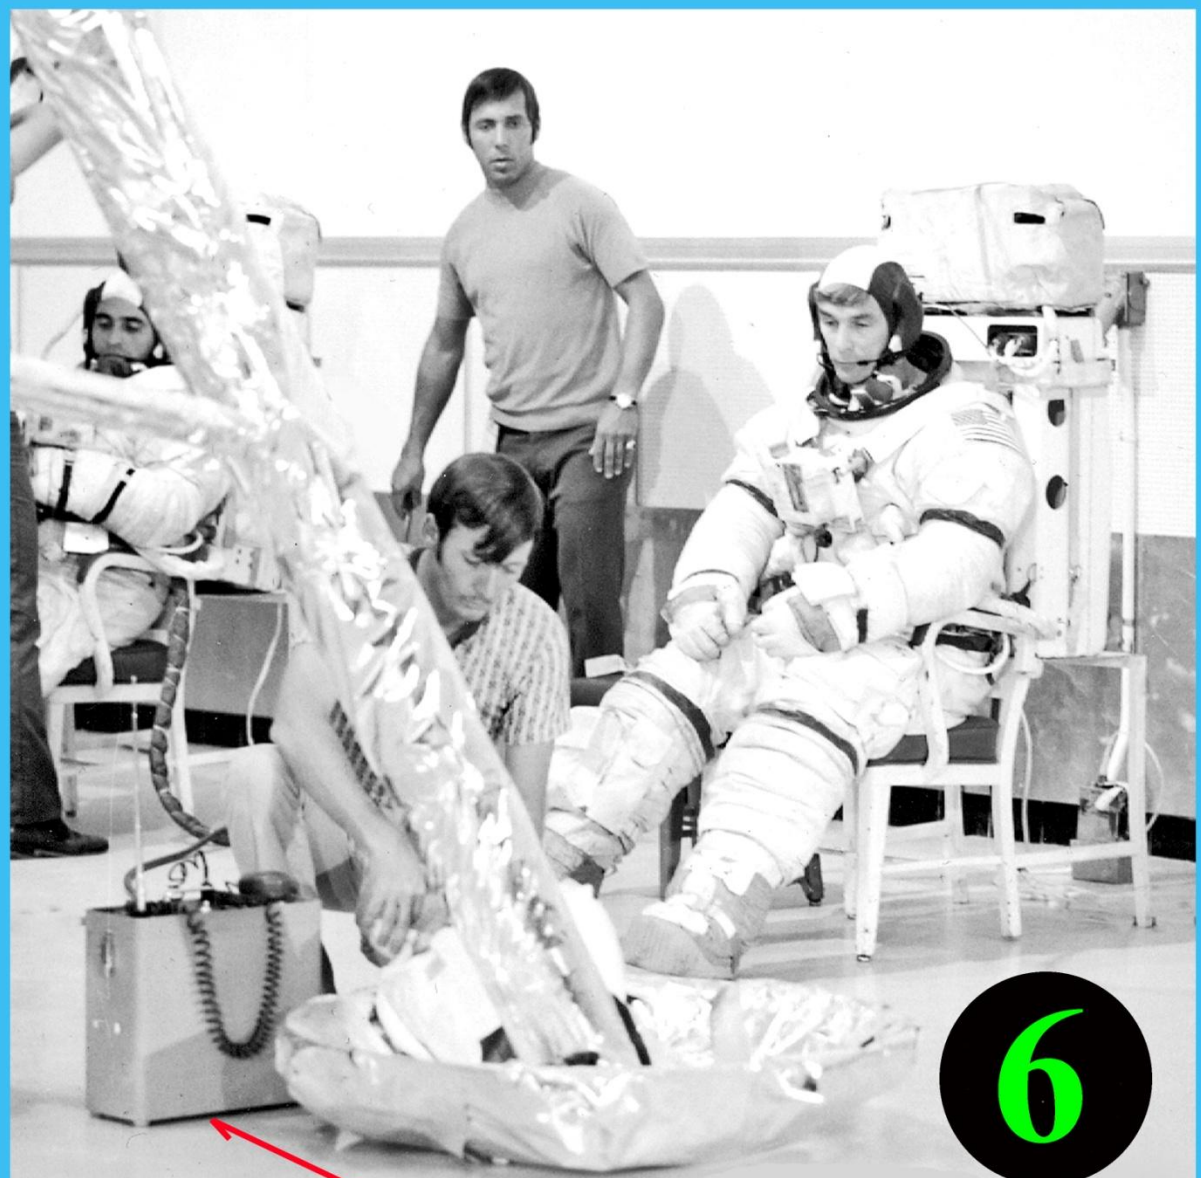
**VOICE
COMM
GROUND
STATION**

Continuing with the functional communications aspect of the EVA training Cryopack, the LM (not literally) was "replaced" by a Ground Station capable of sending and receiving voice communications (Photos 5, 6 and 7). The Ground station had a speaker and a microphone attached to an expandable cord. Speaker voice content could easily be heard within a 20 to 30 foot radius of the station. The Ground station was also portable so it could be carried from one training site to another (see photos 5, 6 and 7 below). For every crew training EVA exercise there were two ground stations, one used by the test conductor and the other used by techs and myself.

STATIONARY GROUND STATION

GROUND STATION CARRIED BY EVA TEST CONDUCTOR

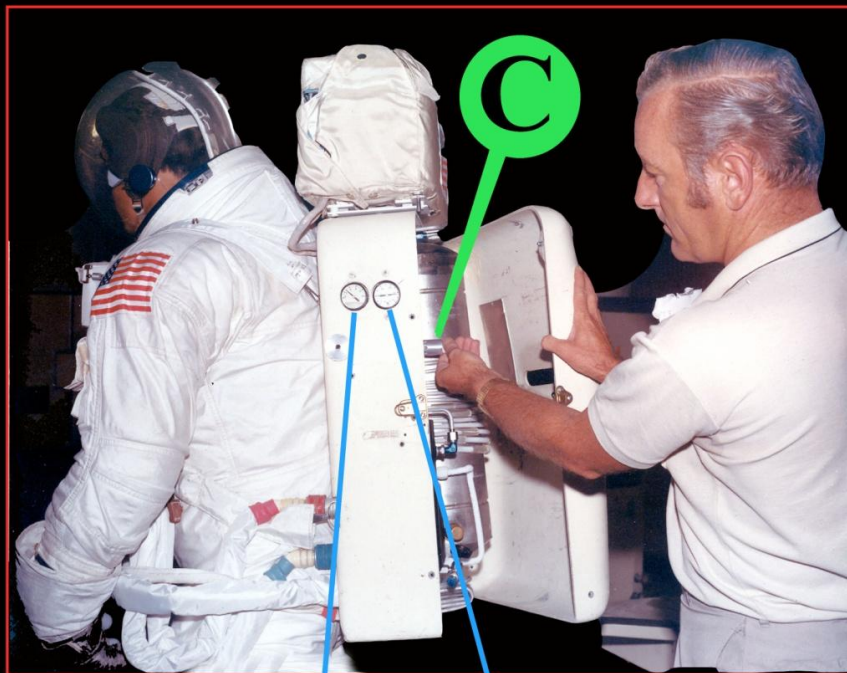
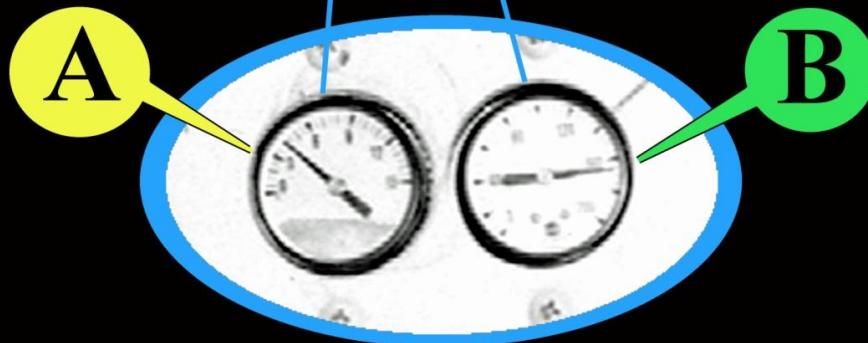
In photo #2, my cryopack tech is turning the suit pressure control valve knob "C" clockwise to increase suit pressure to 3.75 psi. An enlargement of suit pressure gauge "A" shows that it does in fact read 3.75 psi. The enlargement is a little "blurry." I'm sorry for that but it was the best I could do. System pressure gauge "B" shown enlarged, reflects a system pressure of 160 psi (again, a little blurry) which is the nominal cryopack system pressure reading after a full Liquid Air charge.

2 HSD TECH RAISING SUIT PRESSURE TO NOMINAL 3.75 PSI (BY TURNING "SUIT PRESSURE CONTROL VALVE" CLOCKWISE)

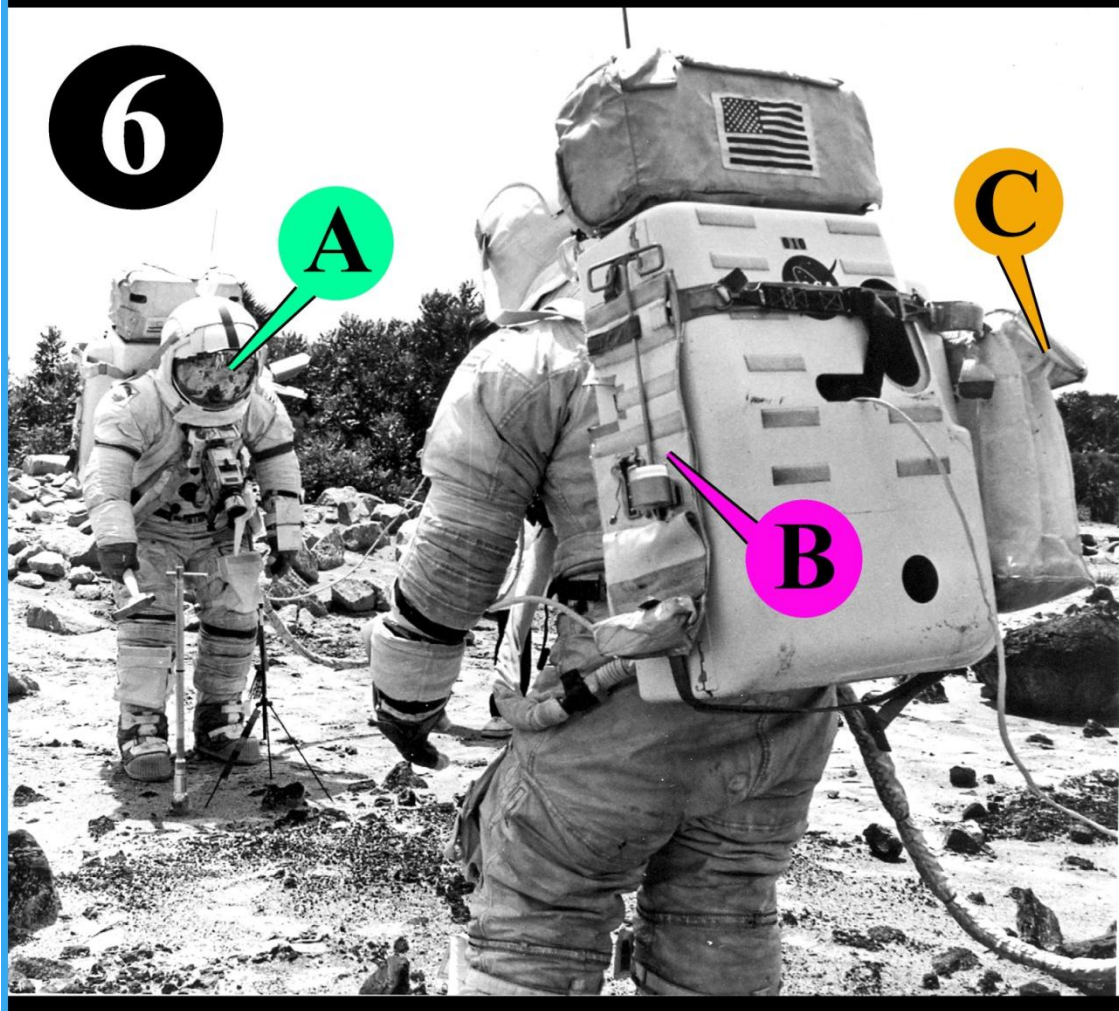
The photo #6 scenario represented a very dangerous "SAFETY" situation. As you can see, not only are the Apollo 17 astronauts Cernan and Schmitt's UV visors "A" down, but the suit pressure and system pressure gauges are covered by a tool holder "B" on one side and a sample bag "C" on the other side (both sides of the cryopack had duplicate gauges).

***GAUGES COVERED**

Communication capability with the astronauts via the portable ground stations was the last "lifeline" remaining to monitor the physiological condition of the crew. We were very cognizant of this situation and I met with each EVA training mission test conductor before the first training exercise for that mission. I discussed my "SAFETY" procedures and in the case of the photo #6 scenario (visors down, gauges blocked), I suggested and they all agreed they would ask the crew if they were okay about every ten (10) minutes. It was agreed that I would keep track of the time and would signal the test conductor by pointing to the crew when I knew I had the attention of the test conductor.
